# ***R.B.G. Home Inspections, LLC***

301 W. Greene Street (Highgate Estates & Gardens)  
Greensboro, Georgia 30642

Prepared for: [Jeff Hough & Jack Rallo](#)

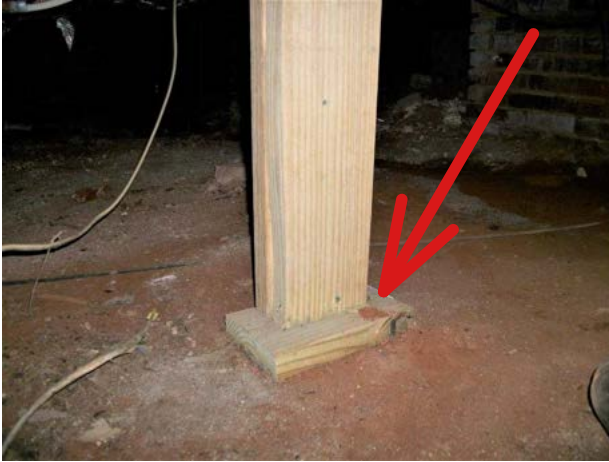
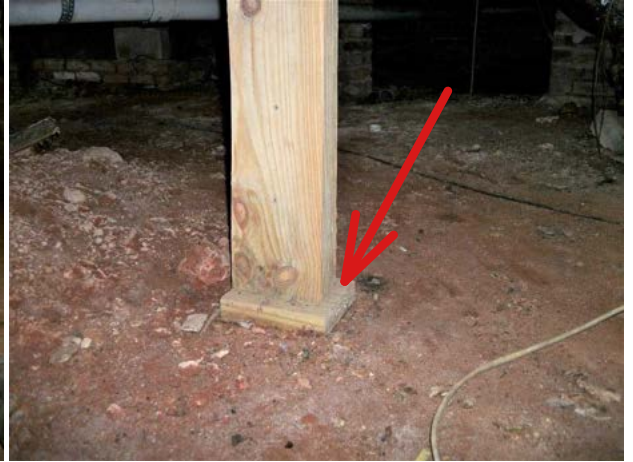
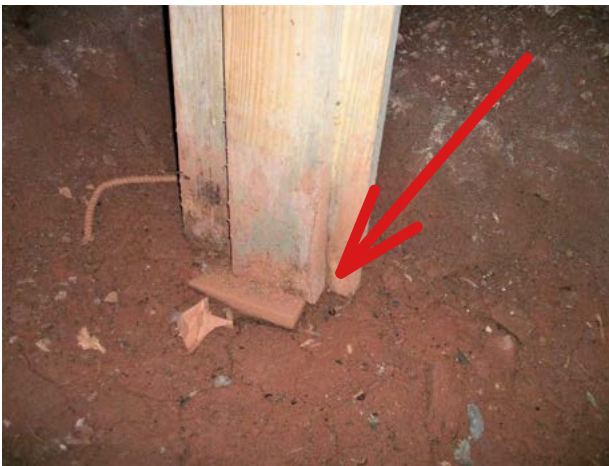
5. ☐ ☐ ☐ ☒ ☐ Framing The vertical support posts in the rear crawl space area under the kitchen were improperly placed on pressure treated blocks or bases instead of in or on concrete footers. Further evaluation and proper repair as needed by a qualified contractor is recommended.

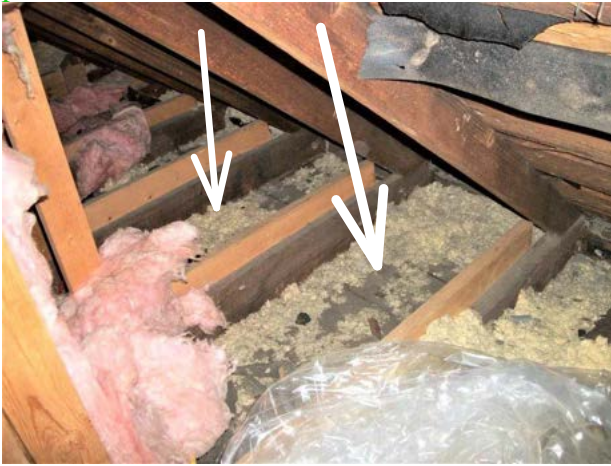
1. Access ☐ Typical ☒ Restricted
2. Method of Inspection: In the attic
3. ☒☐☐☐☐ Ventilation:
4. ☐☐☐☒☐ Insulation: Blown in, & Fiberglass - Small areas of missing and or displaced insulation throughout the attic....creating small "cold/hot" zones. Recommend additional insulation be installed at some point.

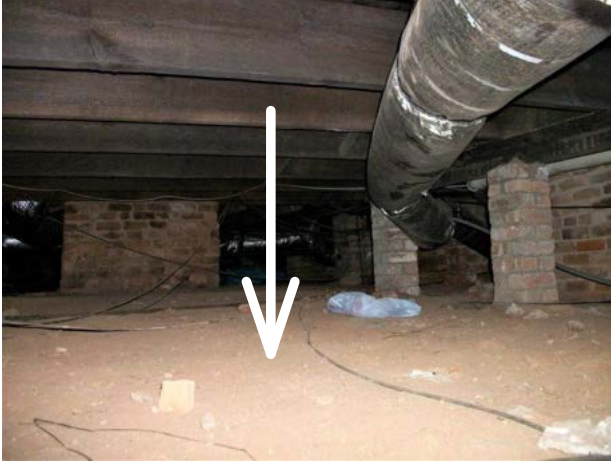
9. ☐☐☐☒☐ Vapor Barrier: No vapor barrier on crawl space floor. Installing proper (6 mil.) vapor barrier for 100% coverage is recommended. Minor correction.

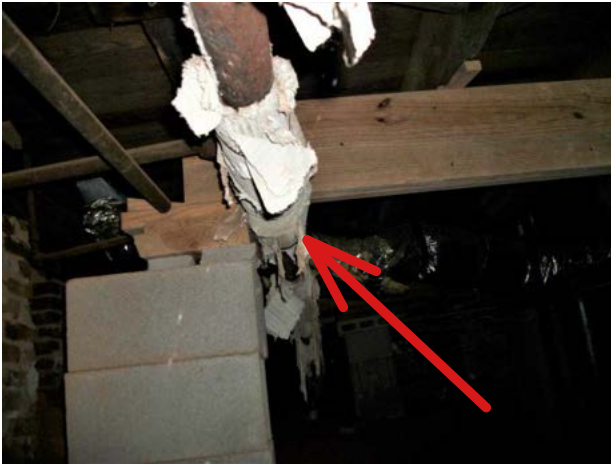
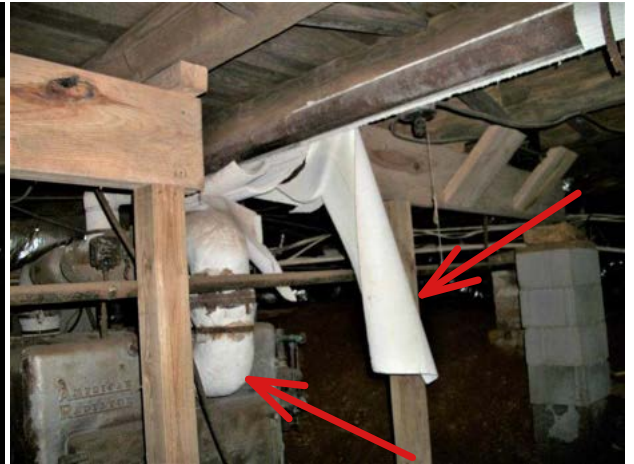
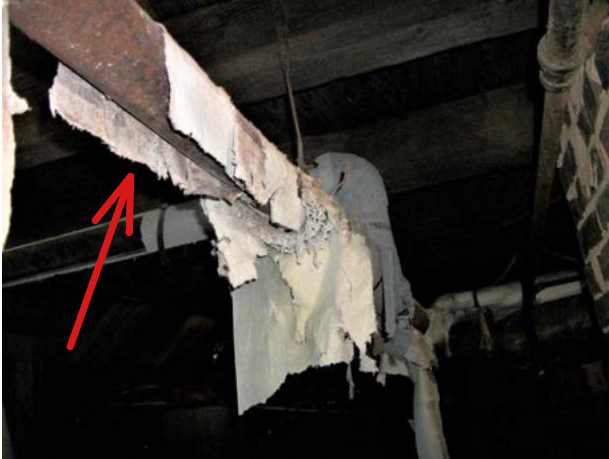
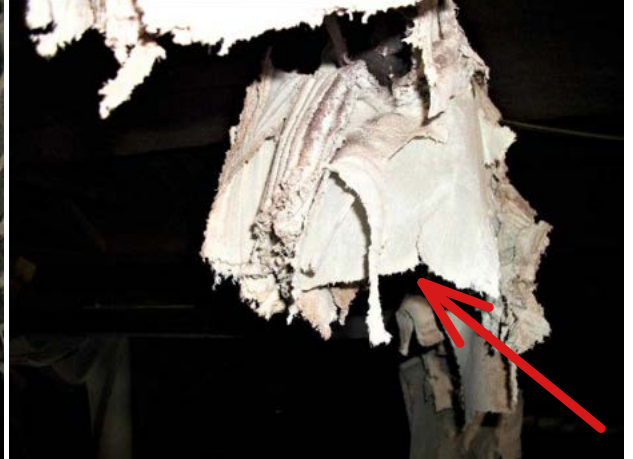
10. ☐☐☐☐☒ Old Boiler Water Lines: CPVC, PVC, Polybutelene - Possible asbestos insulation on the old water supply piping in several areas throughout the crawl space and old boiler area. (see examples) It is damaged and jagged on the edges in several areas and in friable condition which allows the microscopic asbestos fibers to become airborne. A qualified plumber or professional is recommended to properly encapsulate and/or remove.

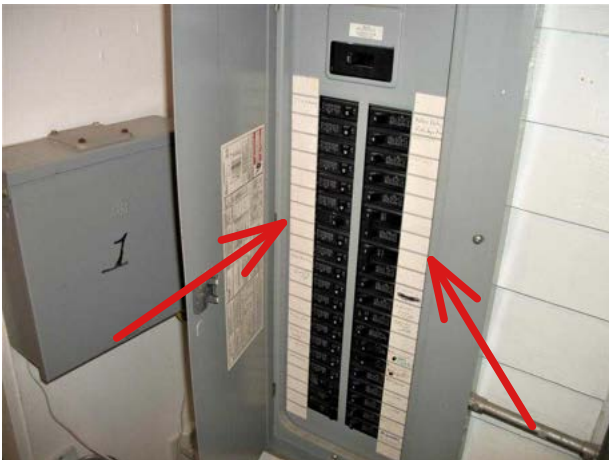
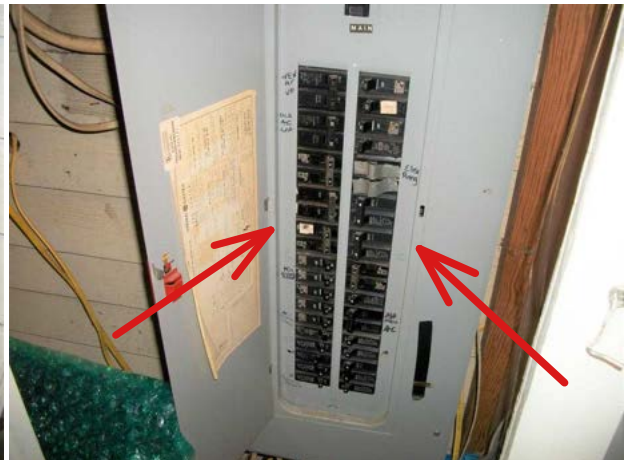
7. ☒ ☐ ☐ ☐ ☐ Aluminum Wiring: Entrance Cable Only (standard)
8. ☐ ☐ ☐ ☒ ☐ Panel Access: FYI - The service panel covers have not been labeled/indexed completely....unable to identify several of the circuits. Having the circuits checked and indexed by a licensed electrician is recommended.

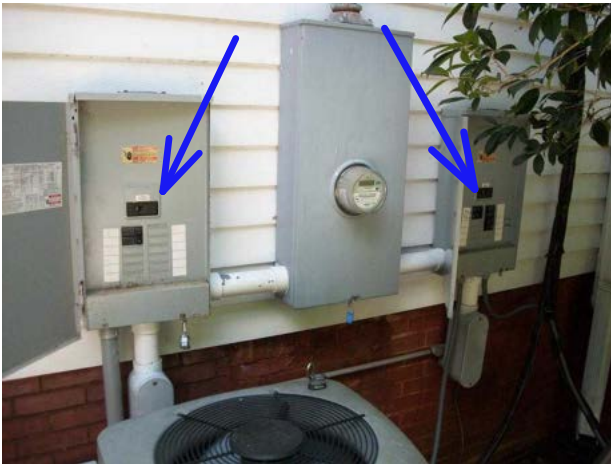
12. ☒ ☐ ☐ ☐ ☐ Main Breaker Size: 200 Amps x 2 (Georgia Power) - **FYI - main service disconnect(s) located at rear of house.**

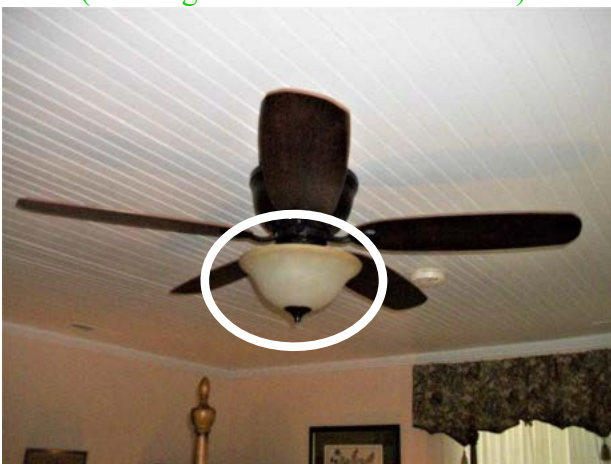
13. ☒ ☐ ☐ ☐ ☐ Breakers: Properly wired and secured
14. ☐ ☐ ☐ ☒ ☐ Lighting Fixtures **Inoperative ceiling fan light fixture(s) at the time of inspection...possibly blown bulbs.(front right bedroom on 2nd level) Minor repair recommended.**

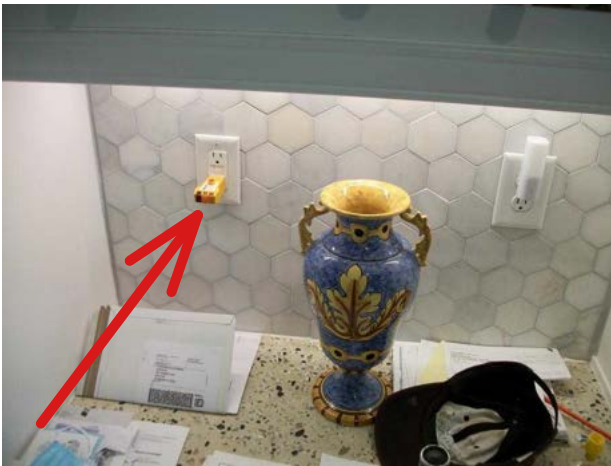
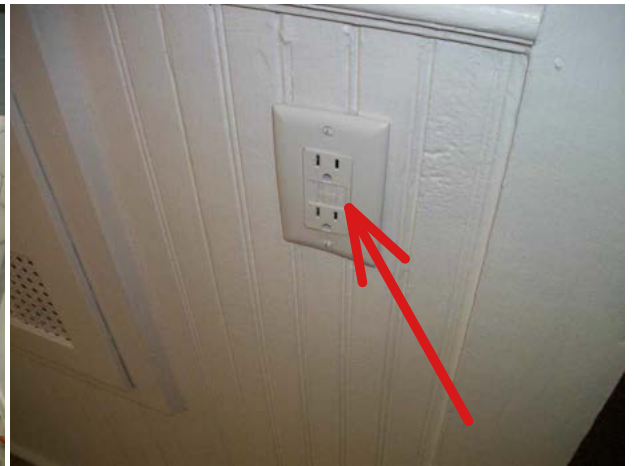
15. ☐☐☐☐☒ Outlets: Three hole type. \*One of the kitchen outlets at the small nook to the left of the vase appeared to be ungrounded.

\*The GFCI receptacle at the rear right bathroom on the main level was not functioning properly at the time of the inspection.....did not trip when tested.

Evaluation and repair of the above items by a licensed electrician is recommended.

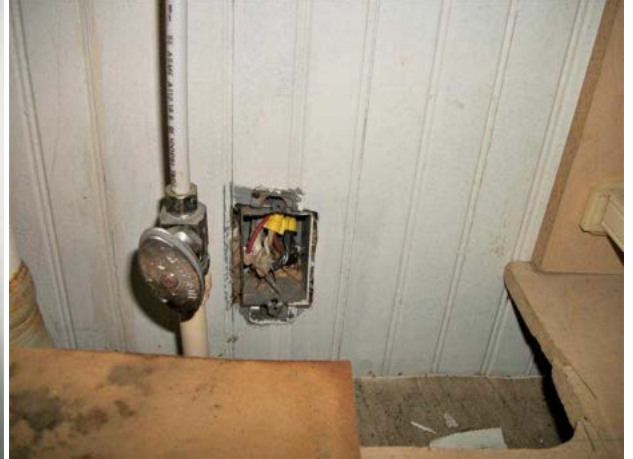
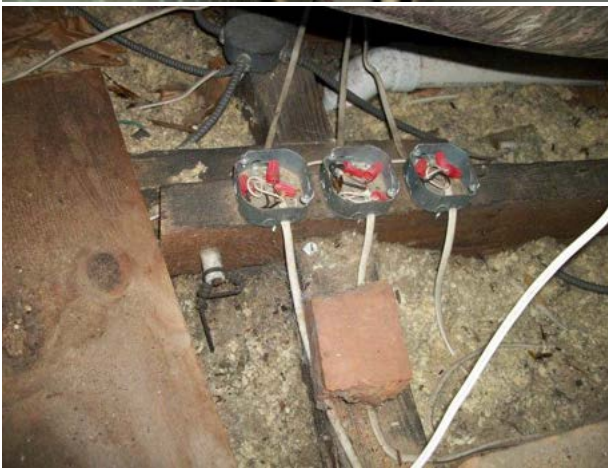
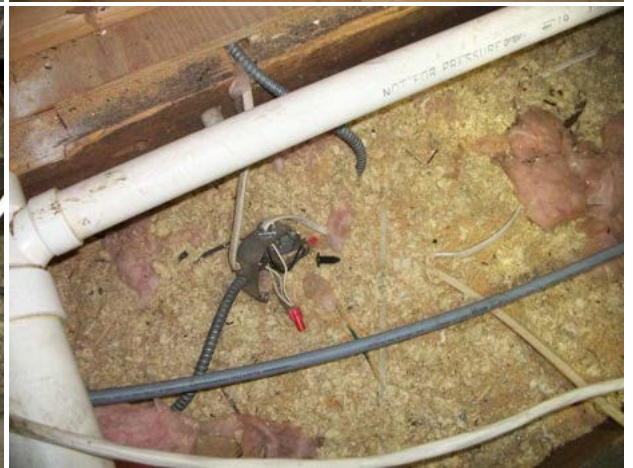
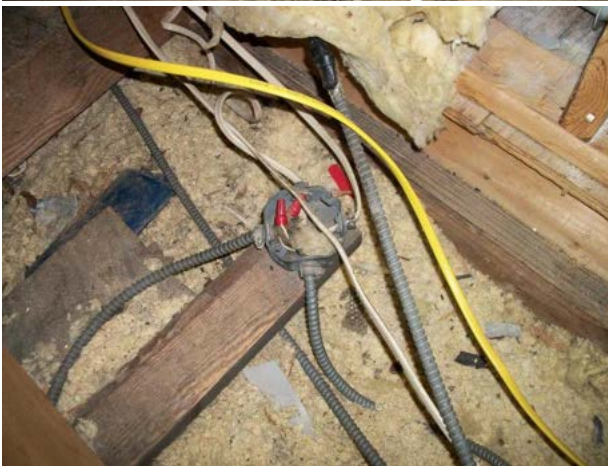
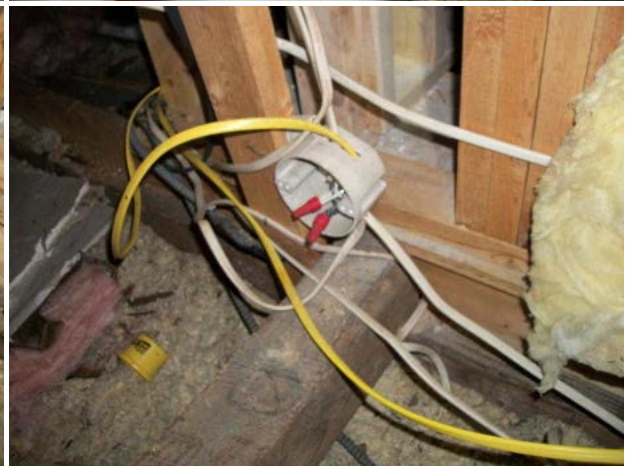
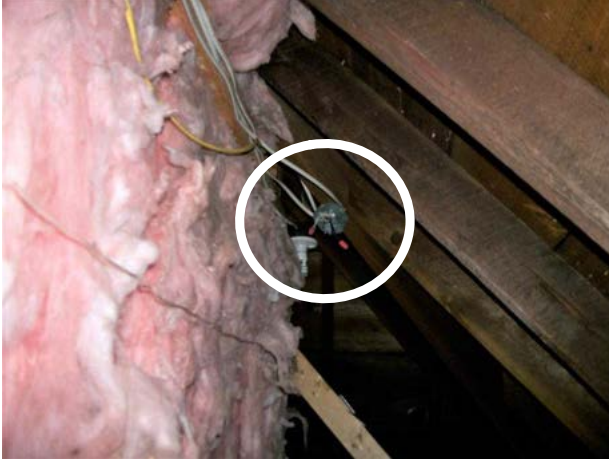
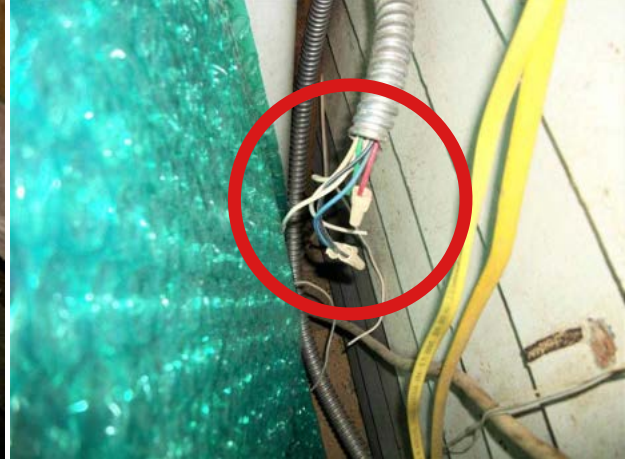
16. ☒☐☐☐☐ Switches/Dimmers:  
17. Fans ☒ Ceiling Paddle ☐ Attic/Thermostat ☐ Whole House ☒ Bath  
18. ☐☐☐☐☒ Wiring -Interior & Attic Copper - Evidence of possibly non-permitted electrical work throughout the interior and attic. Several open junction boxes and loose, unsecured, and improper wire splices throughout....all of which are potential fire hazards. (too many to show all...see sampling below) A full circuit evaluation and repair by a licensed electrician is recommended.  
\*throughout all attic areas  
\*in the rear water heater area  
\*under the rear bathroom sink (on main)  
\*inside the electrical panel closet

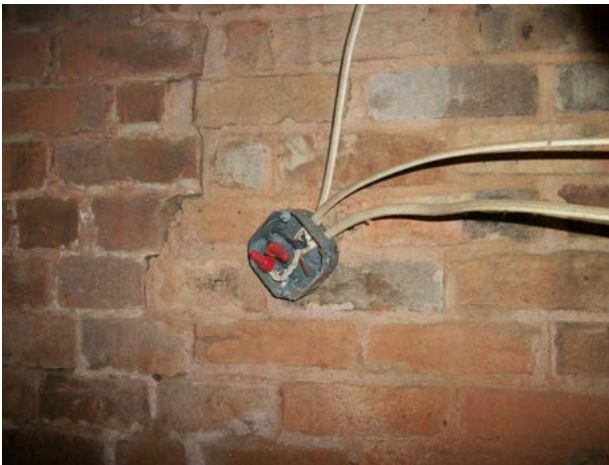
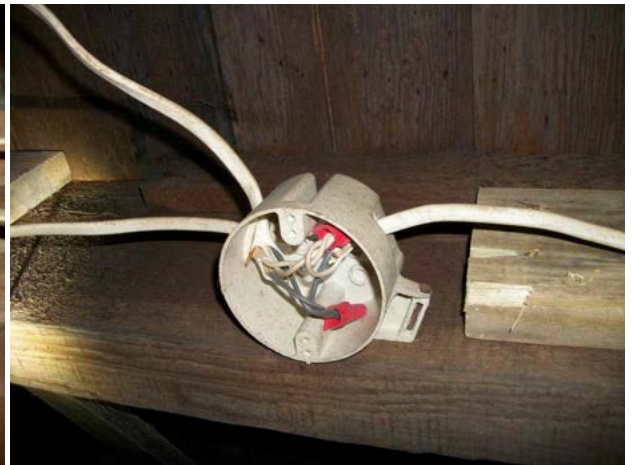
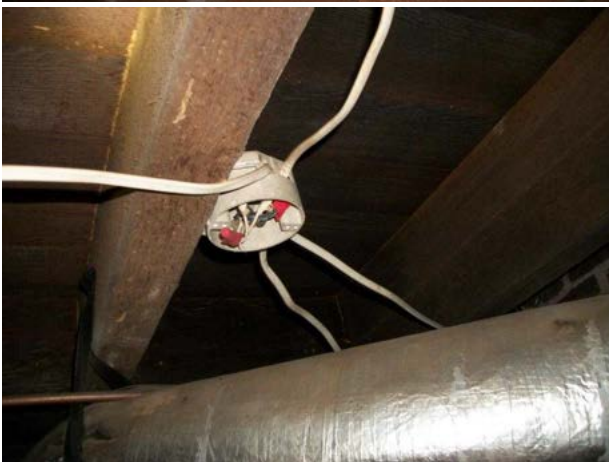
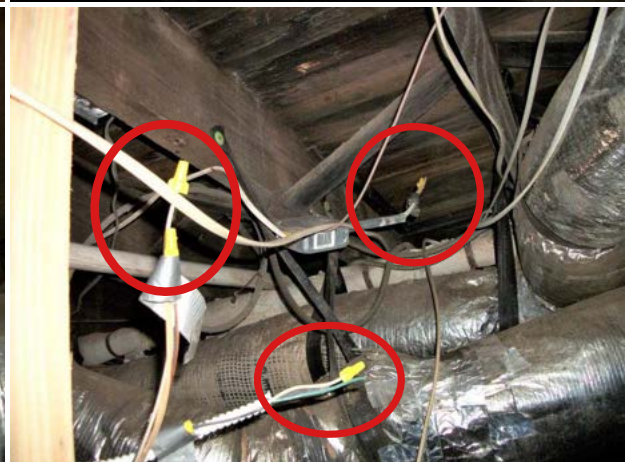
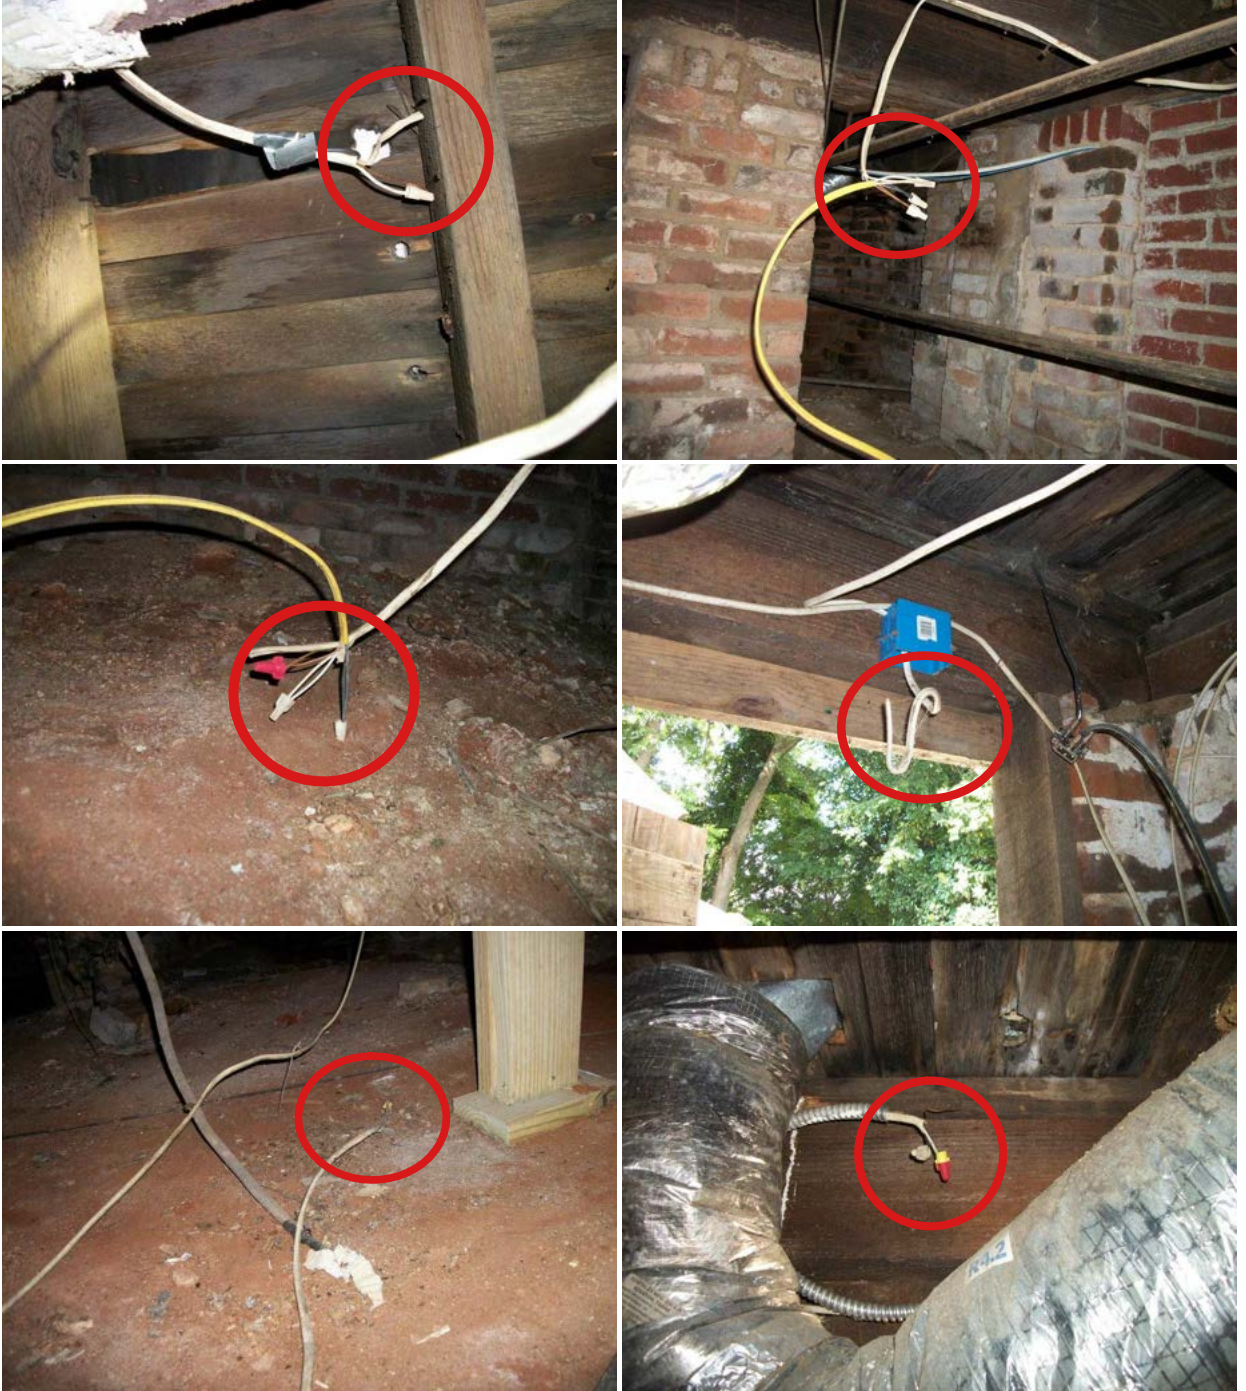
19. ☐ ☐ ☐ ☐ ☒ Wiring - Crawlspace: Copper - Evidence of non-permitted and unsafe electrical work throughout the entire crawl space. Several open junction boxes and loose, unsecured, and improper wire splices throughout....all of which are potential fire and/or contact hazards. (too many to show all...see sampling below) A full circuit evaluation and repair by a licensed electrician is recommended.

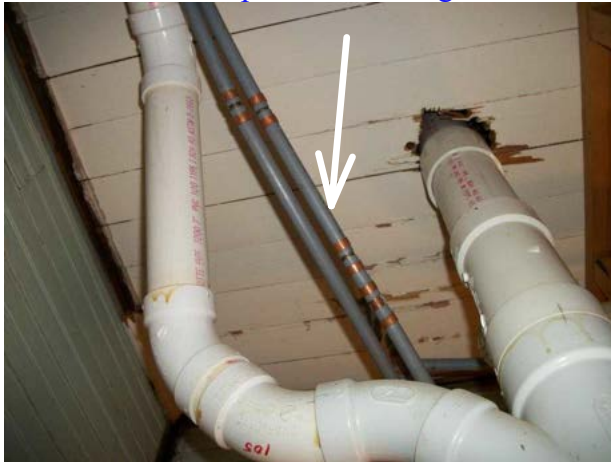
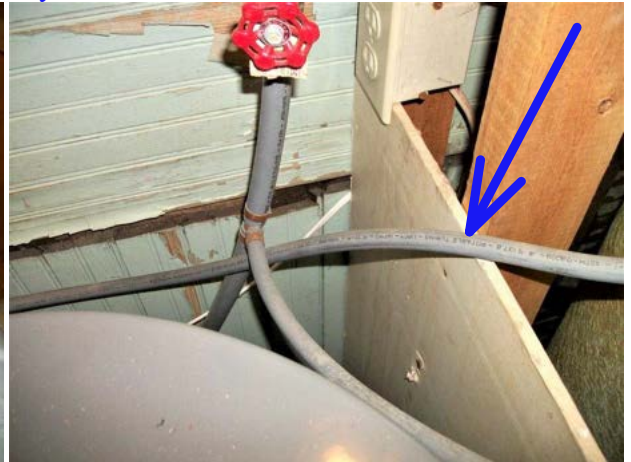
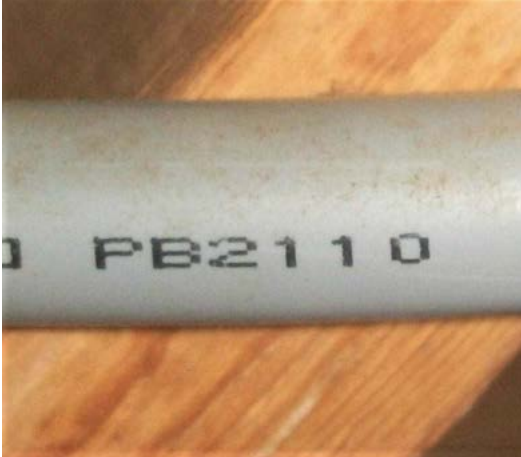
6. ☒ ☐ ☐ ☐ ☐ Service Line: Plastic
7. ☒ ☐ ☐ ☐ ☐ Hose Bibs: Standard
8. ☒ ☐ ☐ ☐ ☐ Main Water Shutoff: Crawl space
9. ☒ ☐ ☐ ☐ ☐ Water Lines: CPVC, PVC, Polybutelene - FYI - Polybutylene plumbing...usually stamped with the code PB2110" is made from a plastic resin that was used extensively in the manufacture of water supply piping from 1978 until 1995. While scientific evidence is scarce, it is believed that oxidants in the public water supplies, such as chlorine, react with the polybutylene piping and fittings causing them to scale and flake and become brittle. Micro-fractures result, and the basic structural integrity of the system is reduced. Thus, the system becomes weak and may fail without warning causing damage to the building structure and personal property. Other factors may also contribute to the failure of polybutylene systems, such as improper installation, but it is virtually impossible to detect installation problems throughout an entire system.

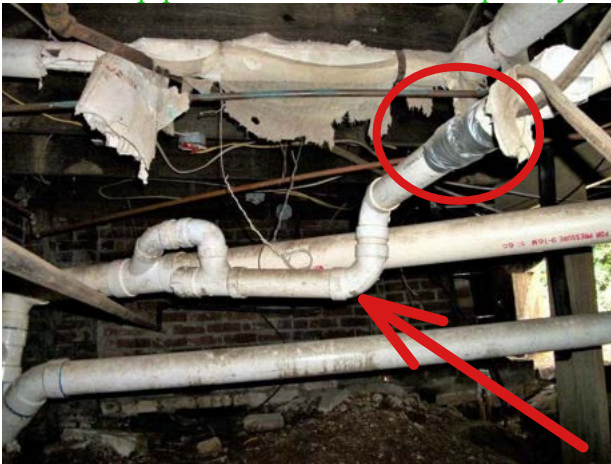
10. ☐☐☐☒☐ Drain Pipes: PVC, Plastic - Drain pipe under kitchen sink slightly misaligned with an upward slope. This condition could potentially cause water, grease/oils, and soap residue to collect in this section of pipe. Further evaluation/repair by licensed plumber is recommended.

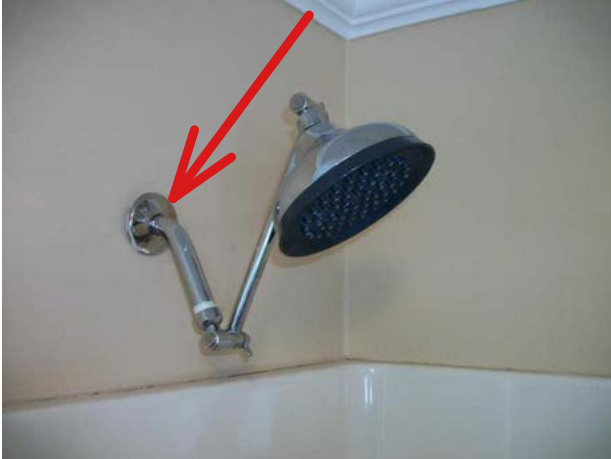
11. ☒☐☐☐☐ Vent Pipes: PVC, Plastic  
12. ☒☐☐☐☐ Kitchen Sink:  
13. ☒☐☐☐☐ Bathroom Sink:  
14. ☐☐☐☒☐ Shower/Baths: Shower head assembly loose and not properly secured to the riser inside the wall at the rear right bathroom on the 2nd level. Further evaluation/correction by a licensed plumbing contractor is recommended.

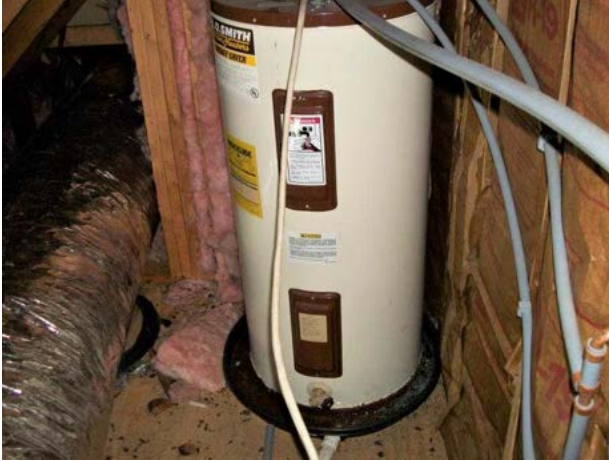
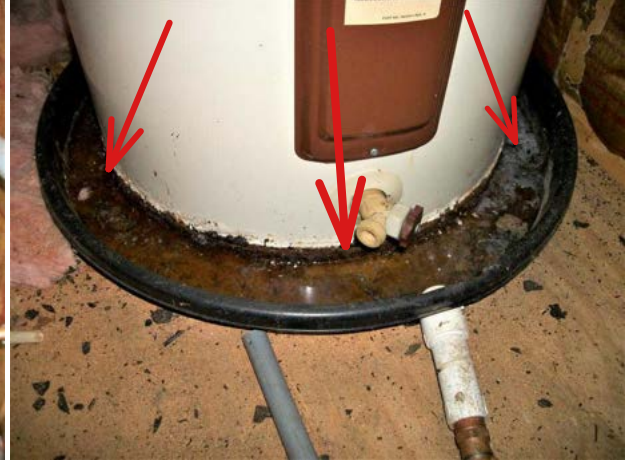
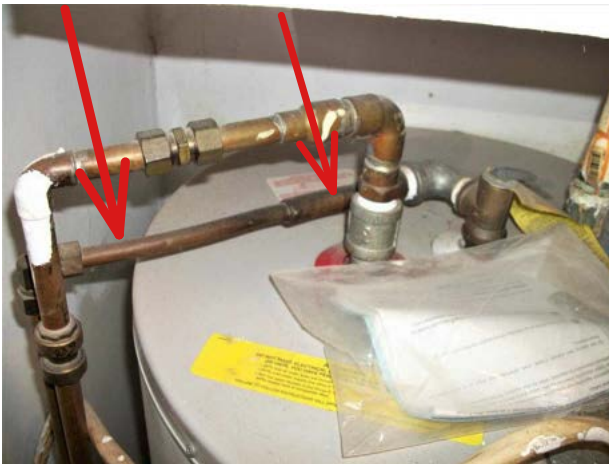
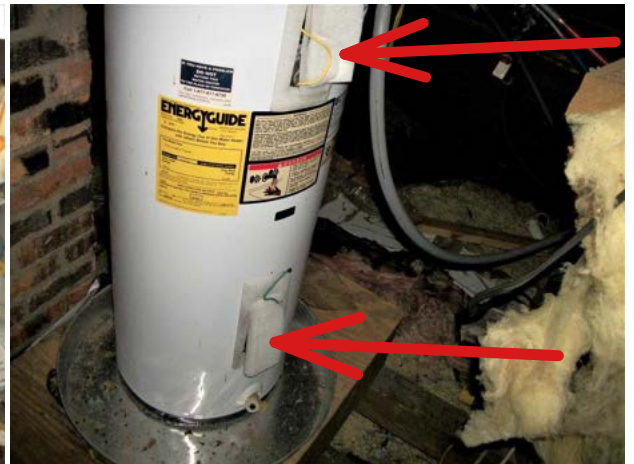
16. ☐ ☐ ☐ ☐ ☒ Water Heater Operation: All water heaters were functional at the time of the inspection (4 total) But there were some issue with a few of them. See below.

\*The oldest unit located in the front attic area was functional at the time of the inspection but appears to be at the end of it's useful life as it has rusted out around the bottom and started to leak...pooling water inside the drip pan at the time of the inspection.

\*The TPRV (Temperature Pressure Relief Valve) at the rear hallway water heater has been improperly plumbed. The TPRV discharge pipe has been reduced down from 3/4" to 1/4" copper tubing. The TPRV is a safety devise and should never be reduced as the size of the discharge pipe must match the opening size of the TPR valve discharge.

\*The protective thermostat cover(s) at the rear attic water heater have been removed...not installed on water heater at the time of the inspection. This leaves an opening to the energized wiring behind the panel cover(s) ...a potential contact hazard. Installing protective cover(s) recommended.

Further evaluation of the above items and repair/correction as needed by a licensed plumbing contractor is recommended.

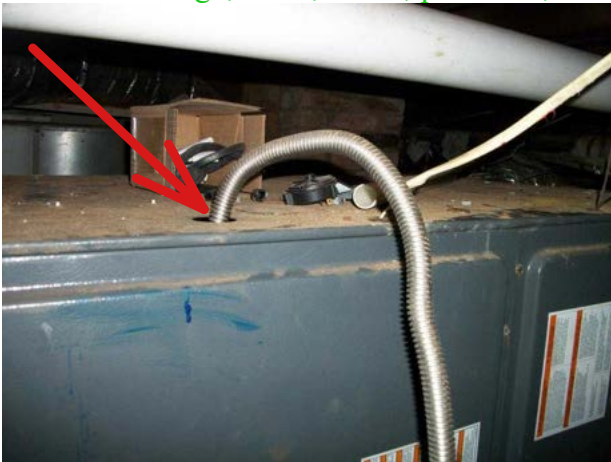
7. Fuel Type: Natural gas x's 2, Heat Pump x's 1
8. ☒☐☐☐☐ Heat Exchanger:
9. ☒☐☐☐☐ Thermostats: Three (3)
10. ☒☐☐☐☐ Main Coolant Line
11. ☐☐☐☒☐ Gas Supply Line FYI - Flexible gas supply line at the furnace in the crawl space and extending through the furnace housing. Be advised that this is no longer allowed under current code because the gas connector flex line is thin wall tubing and as such any vibration from the the furnace rubbing on the connector will eventually result in a leak. In some cases the gas utility company will yellow tag the furnace if the flex is running through the furnace housing and will not turn the gas service on to the house until this is corrected. They typically require black hard pipe be installed and extended through the housing. Minor correction/upgrade recommended.

NOTE: Prohibited locations and penetrations...Connectors shall not be concealed within, or extended through, walls, floors, partitions, ceilings or appliance housings.

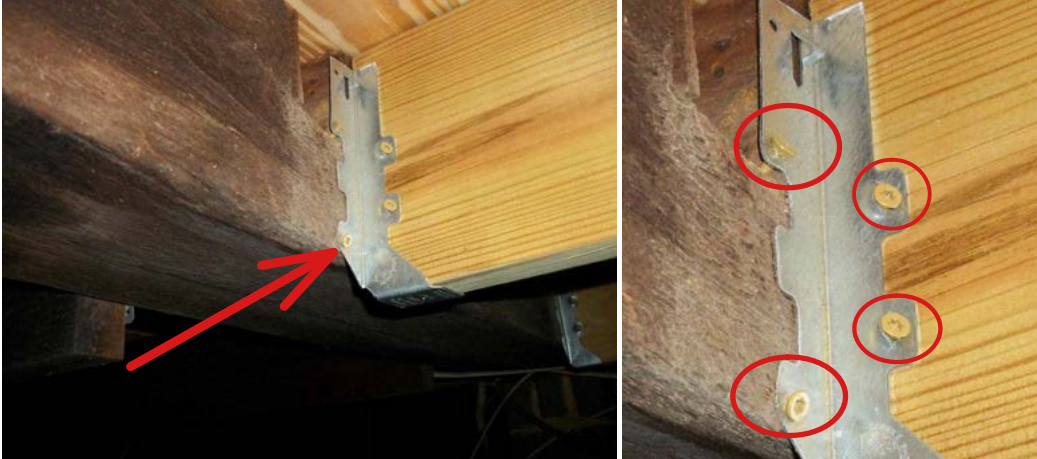
13. ☐ ☐ ☐ ☒ ☐ Decks/Porches/Patios: FYI - It appears that common coated deck screws have been improperly used to install the joist hangers under the veranda. (see example) Joist hangers only meet their performance standards if you install them with the correct fasteners.

Will they hold and secure the joist hangers?...certainly. Although common deck screws have great holding power, they tend to break more easily than do nails under shear stress. Shear stress is force exerted across the fastener's shank in a back-and-forth direction. Joist hangers are designed to sway gently if they're subjected to shear forces, such as during an earthquake or exceptionally high winds. Regular deck screws often consist of hardened steel, which might snap under such stress. Although specialty screws are available for joist hangers, hanger manufacturers typically advise against using common deck screws for installing their products. Note that the most reliable way to determine the right fastener for a particular product is to consult the manufacturer's guidelines.

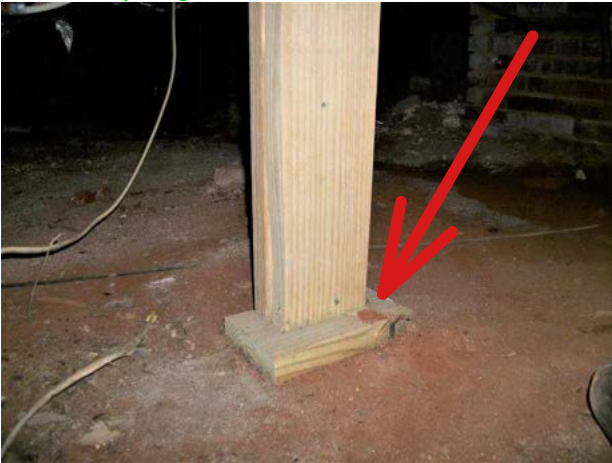
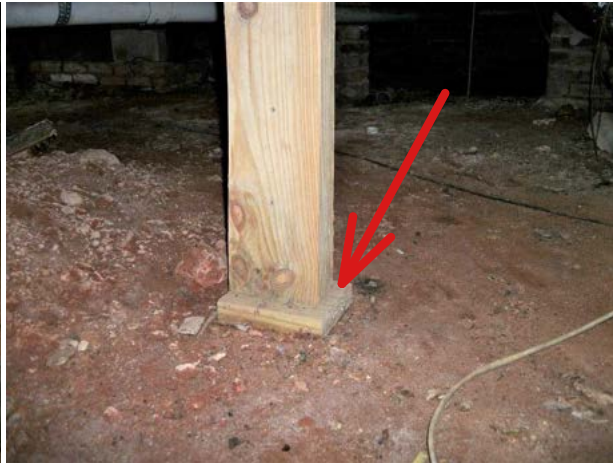
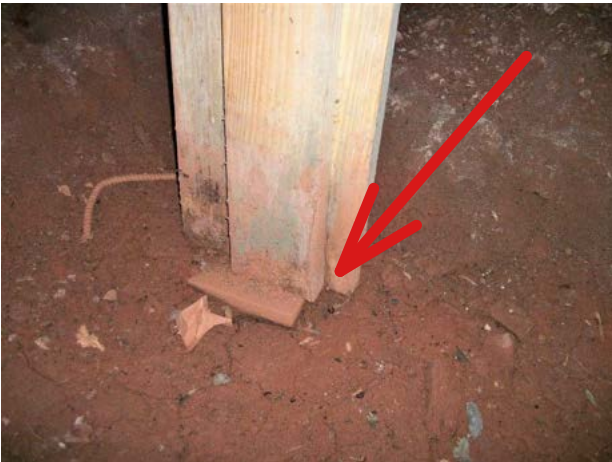
1. Framing The vertical support posts in the rear crawl space area under the kitchen were improperly placed on pressure treated blocks or bases instead of in or on concrete footers. Further evaluation and proper repair as needed by a qualified contractor is recommended.

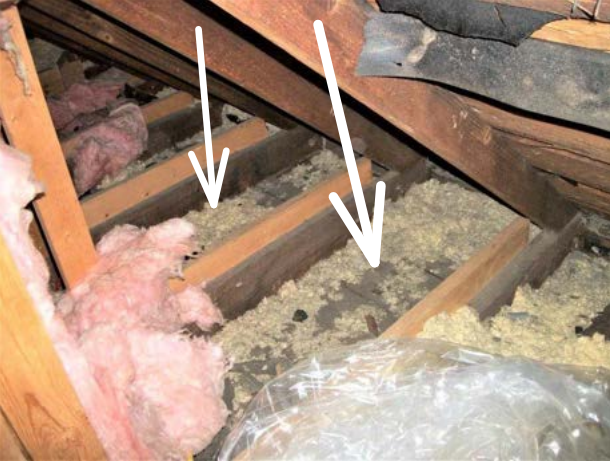
2. Attic Insulation: Blown in, & Fiberglass - Small areas of missing and or displaced insulation throughout the attic....creating small "cold/hot" zones. Recommend additional insulation be installed at some point.

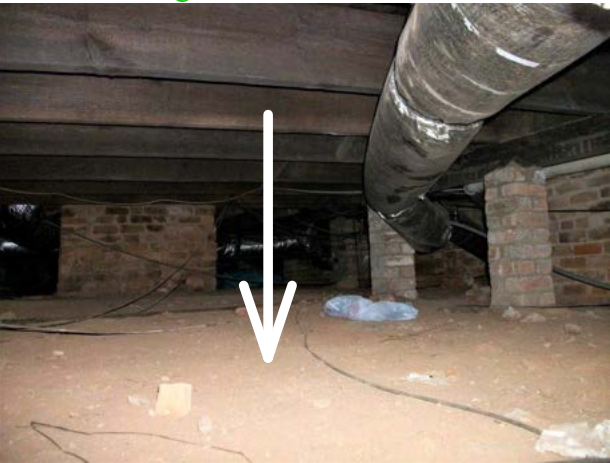
3. Crawl Space Vapor Barrier: No vapor barrier on crawl space floor. Installing proper (6 mil.) vapor barrier for 100% coverage is recommended. Minor correction.

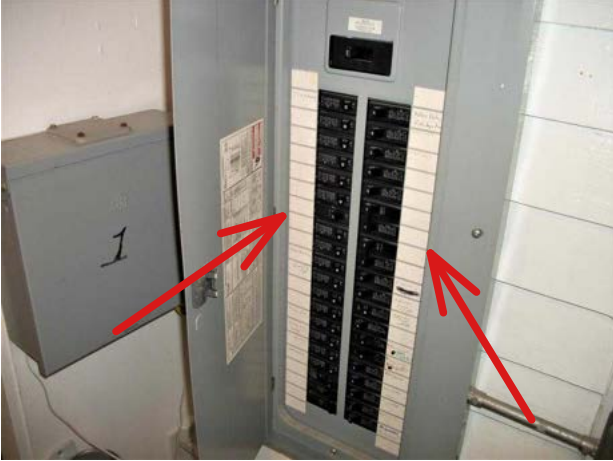
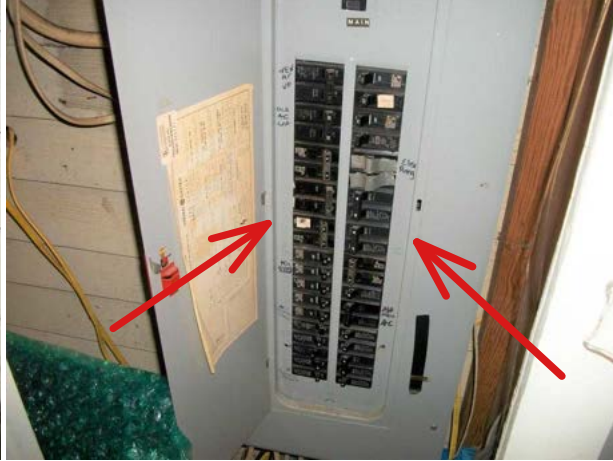
4. Panel Access: FYI - The service panel covers have not been labeled/indexed completely....unable to identify several of the circuits. Having the circuits checked and indexed by a licensed electrician is recommended.

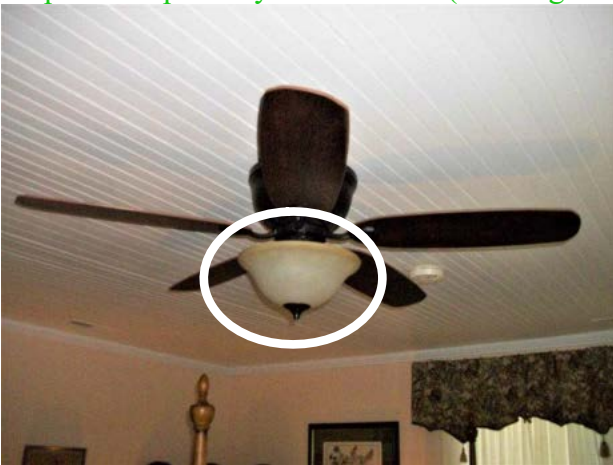
5. Laundry room Electric Panel Lighting Fixtures Inoperative ceiling fan light fixture(s) at the time of inspection...possibly blown bulbs.(front right bedroom on 2nd level) Minor repair recommended.

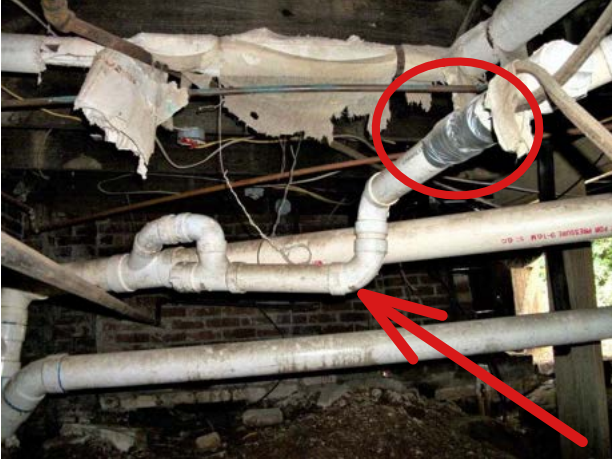
6. Drain Pipes: PVC, Plastic - Drain pipe under kitchen sink slightly misaligned with an upward slope. This condition could potentially cause water, grease/oils, and soap residue to collect in this section of pipe. Further evaluation/repair by licensed plumber is recommended.

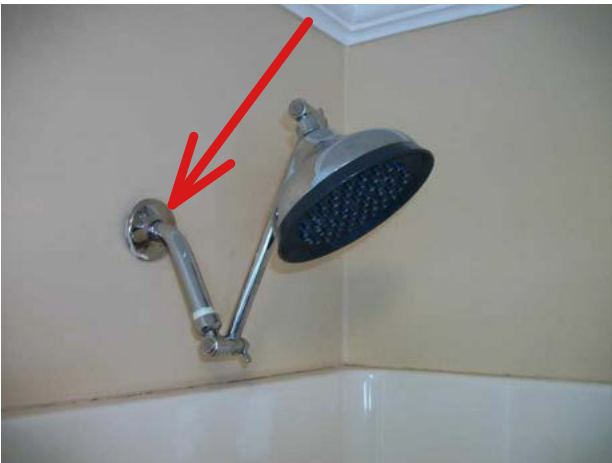
7. Shower/Baths: Shower head assembly loose and not properly secured to the riser inside the wall at the rear right bathroom on the 2nd level. Further evaluation/correction by a licensed plumbing contractor is recommended.

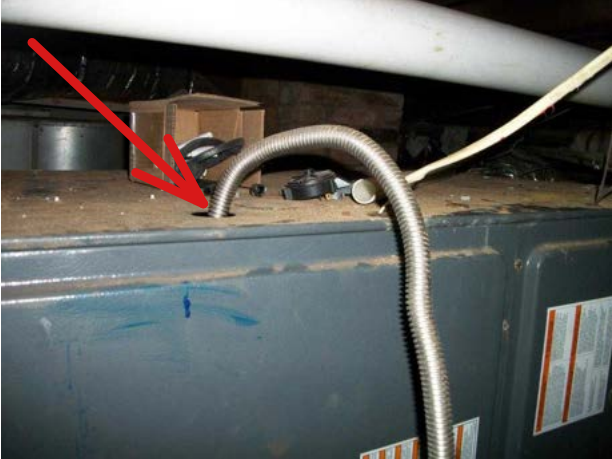
Line FYI - Flexible gas supply line at the furnace in the crawl space and extending through the furnace housing. Be advised that this is no longer allowed under current code because the gas connector flex line is thin wall tubing and as such any vibration from the the furnace rubbing on the connector will eventually result in a leak. In some cases the gas utility company will yellow tag the furnace if the flex is running through the furnace housing and will not turn the gas service on to the house until this is corrected. They typically require black hard pipe be installed and extended through the housing. Minor correction/upgrade recommended.

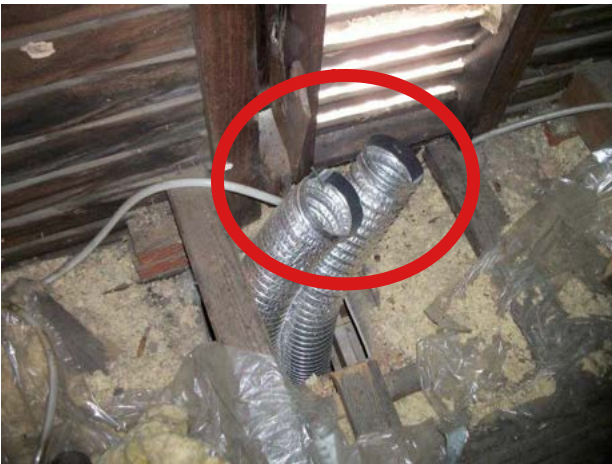
9. Kitchen Exhaust Fan External Discharge- Functional at time of inspection - Cooktop exhaust fan improperly venting into the attic. Ducts serving range or cooktop hoods shall not terminate in an attic or crawl space or areas inside the building. Also, foil flex duct has been improperly installed for the cooktop exhaust fan. Foil flex duct is not advised in this application as should not be used (as typically stated on the ductwork from the manufacturer) . Installing rigid metal or rigid flex duct is usually the preferred and recommended material for kitchen exhaust. Further evaluation and correction as needed is recommended.

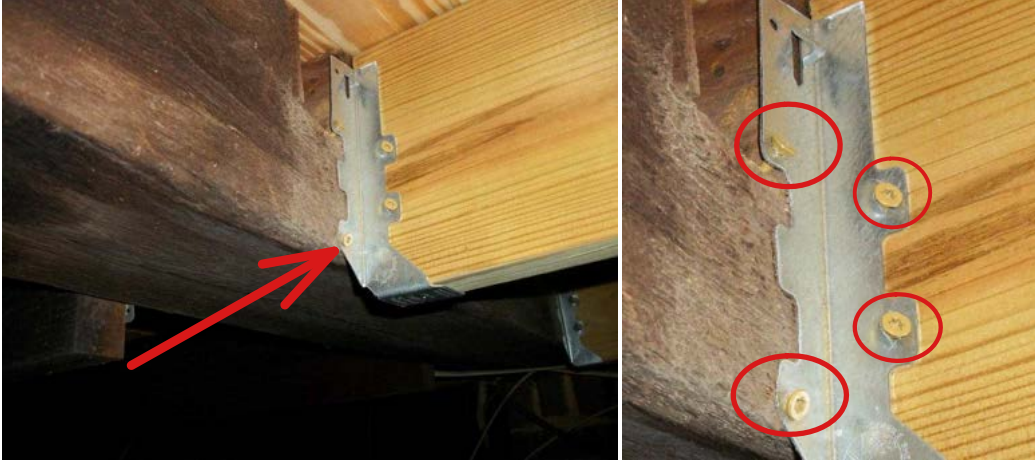
10. No Garage Garage Decks/Porches/Patios: FYI - It appears that common coated deck screws have been improperly used to install the joist hangers under the veranda. (see example) Joist hangers only meet their performance standards if you install them with the correct fasteners.

manufacturers typically advise against using common deck screws for installing their products. Note that the most reliable way to determine the right fastener for a particular product is to consult the manufacturer's guidelines.

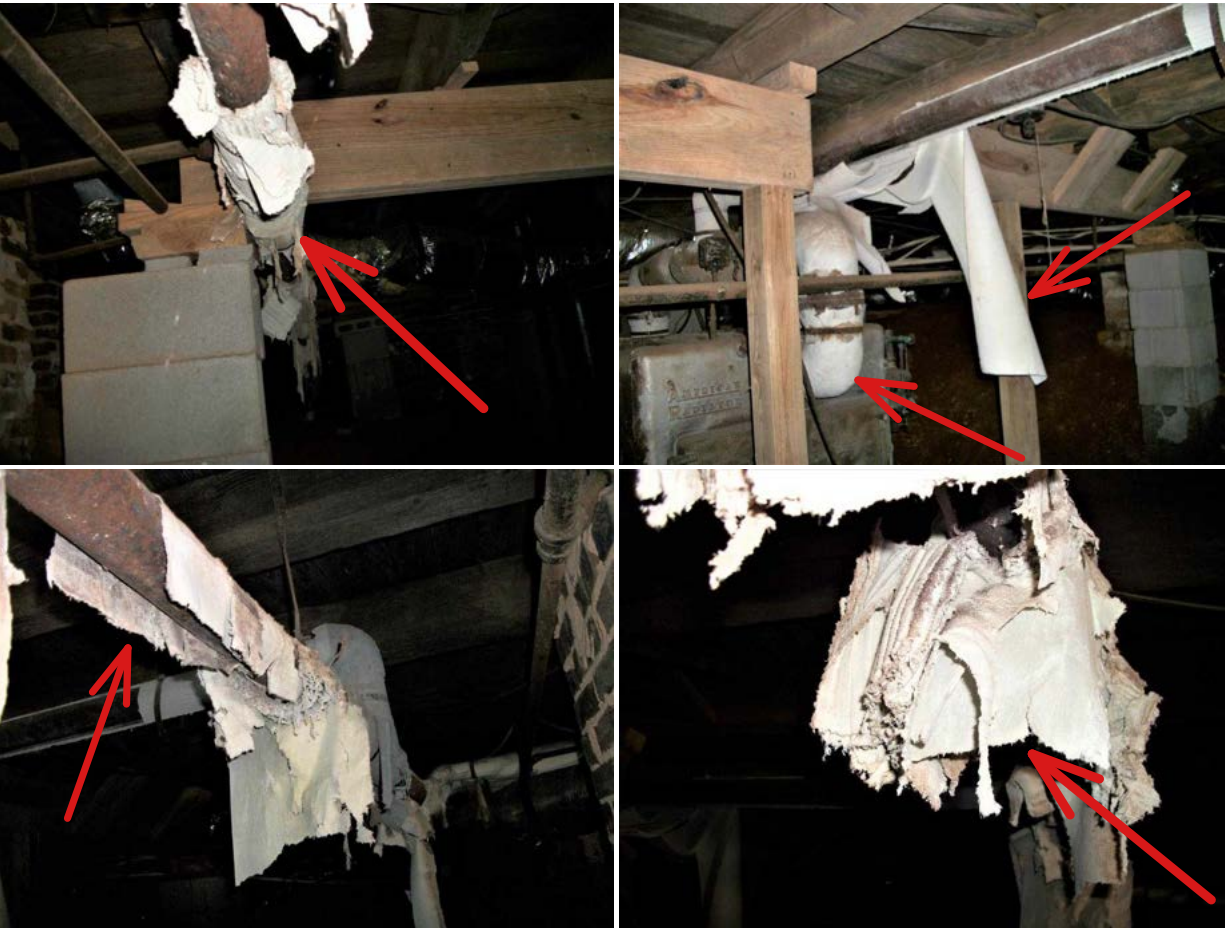
1. Old Boiler Water Lines: CPVC, PVC, Polybutelene - Possible asbestos insulation on the old water supply piping in several areas throughout the crawl space and old boiler area. (see examples) It is damaged and jagged on the edges in several areas and in friable condition which allows the microscopic asbestos fibers to become airborne. A qualified plumber or professional is recommended to properly encapsulate and/or remove.

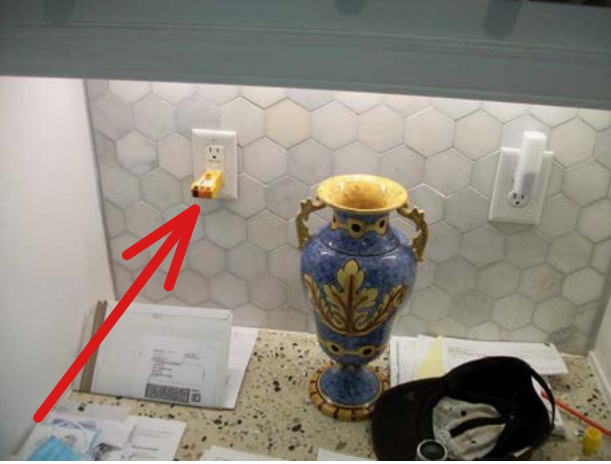
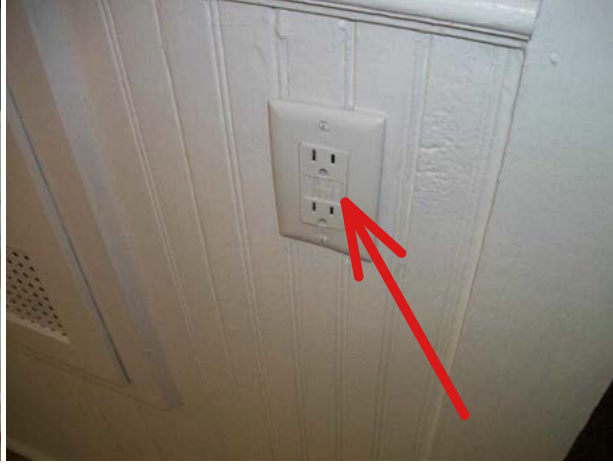
2. Laundry room Electric Panel Outlets: Three hole type. \*One of the kitchen outlets at the small nook to the left of the vase appeared to be ungrounded.

Evaluation and repair of the above items by a licensed electrician is recommended.
