# ***R.B.G. Home Inspections, LLC***

301 W. Greene Street (Highgate Estates & Gardens)  
Greensboro, Georgia 30642

Prepared for: [Jeff Hough & Jack Rallo](#)

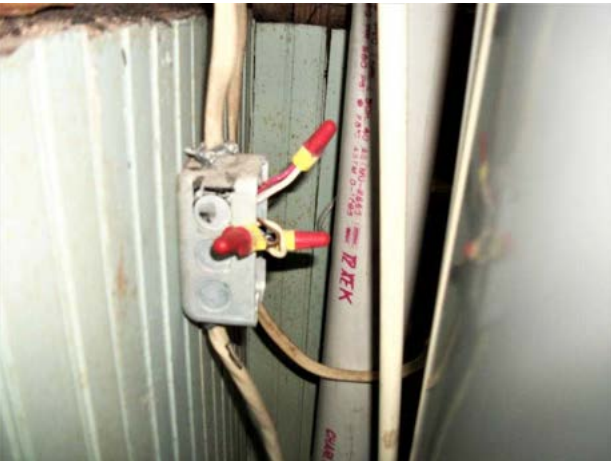
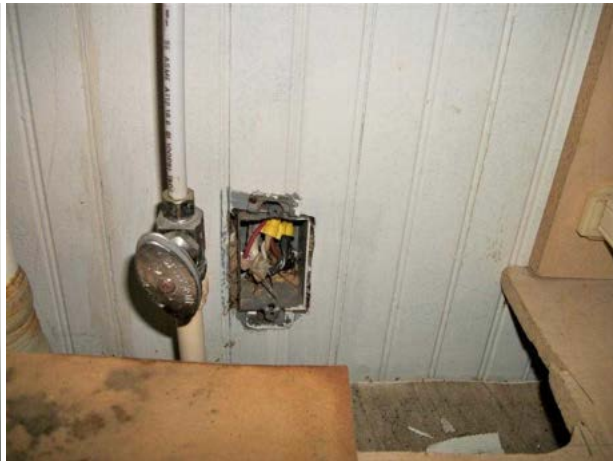
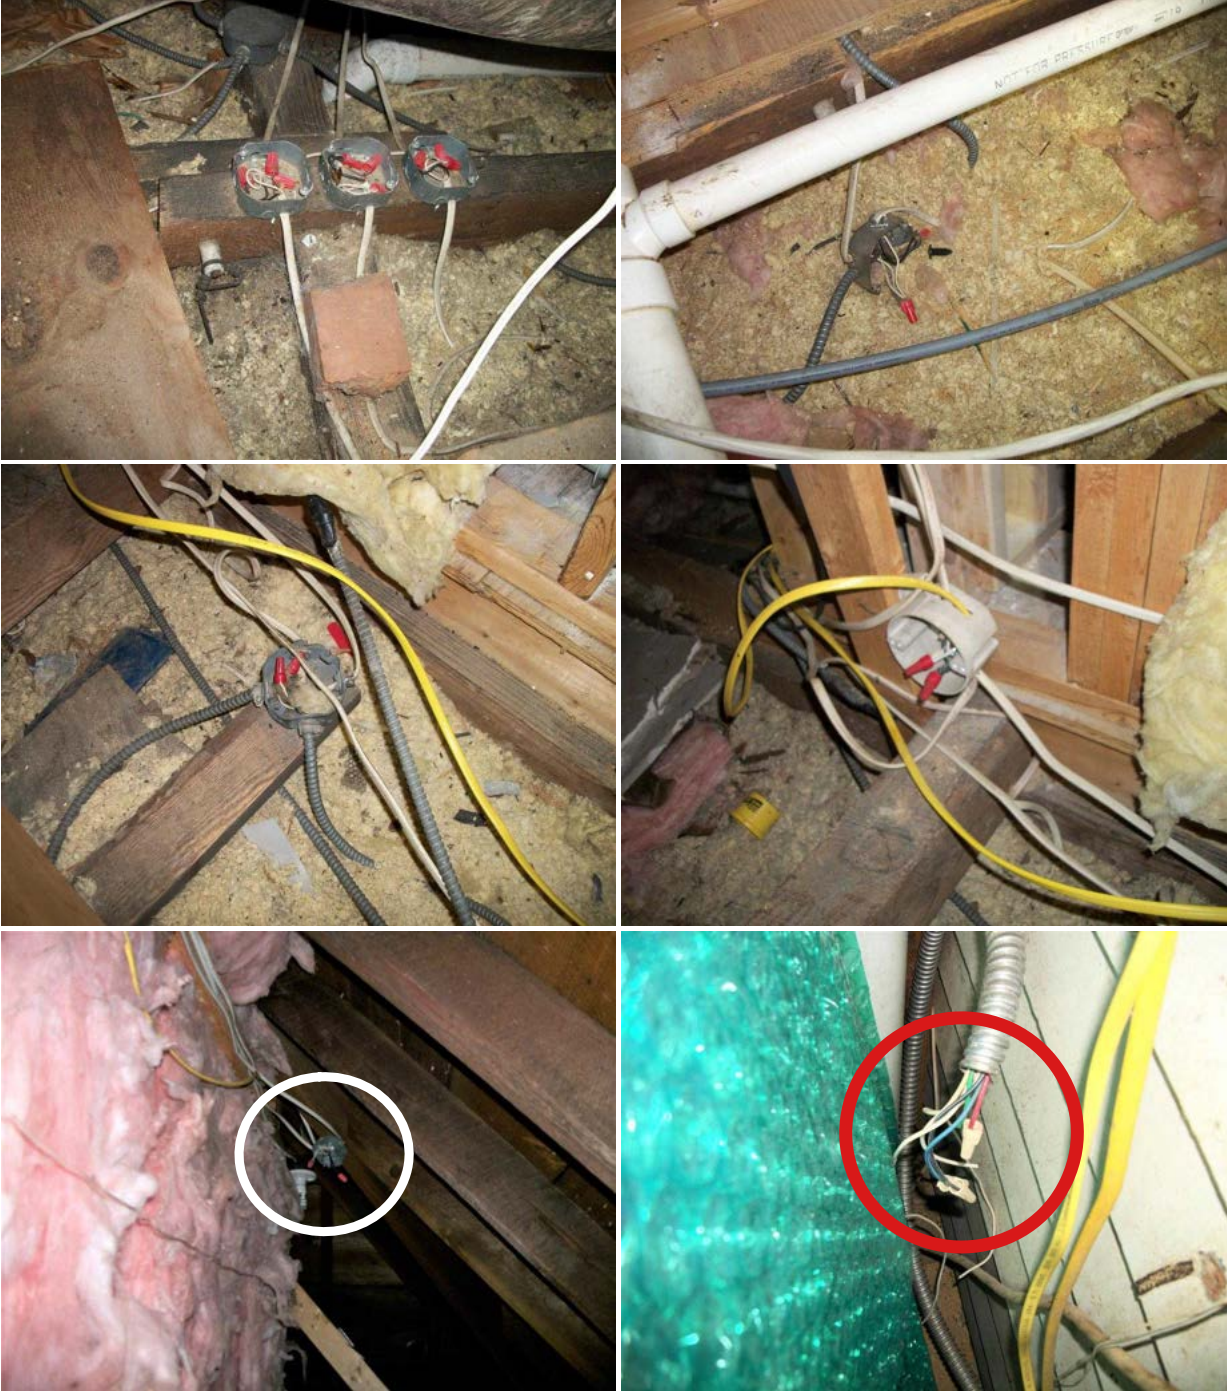
3. Laundry room Electric Panel Wiring -Interior & Attic Copper - Evidence of possibly non-permitted electrical work throughout the interior and attic. Several open junction boxes and loose, unsecured, and improper wire splices throughout....all of which are potential fire hazards. (too many to show all...see sampling below) A full circuit evaluation and repair by a licensed electrician is recommended.

- \*throughout all attic areas
- \*in the rear water heater area
- \*under the rear bathroom sink (on main)
- \*inside the electrical panel closet

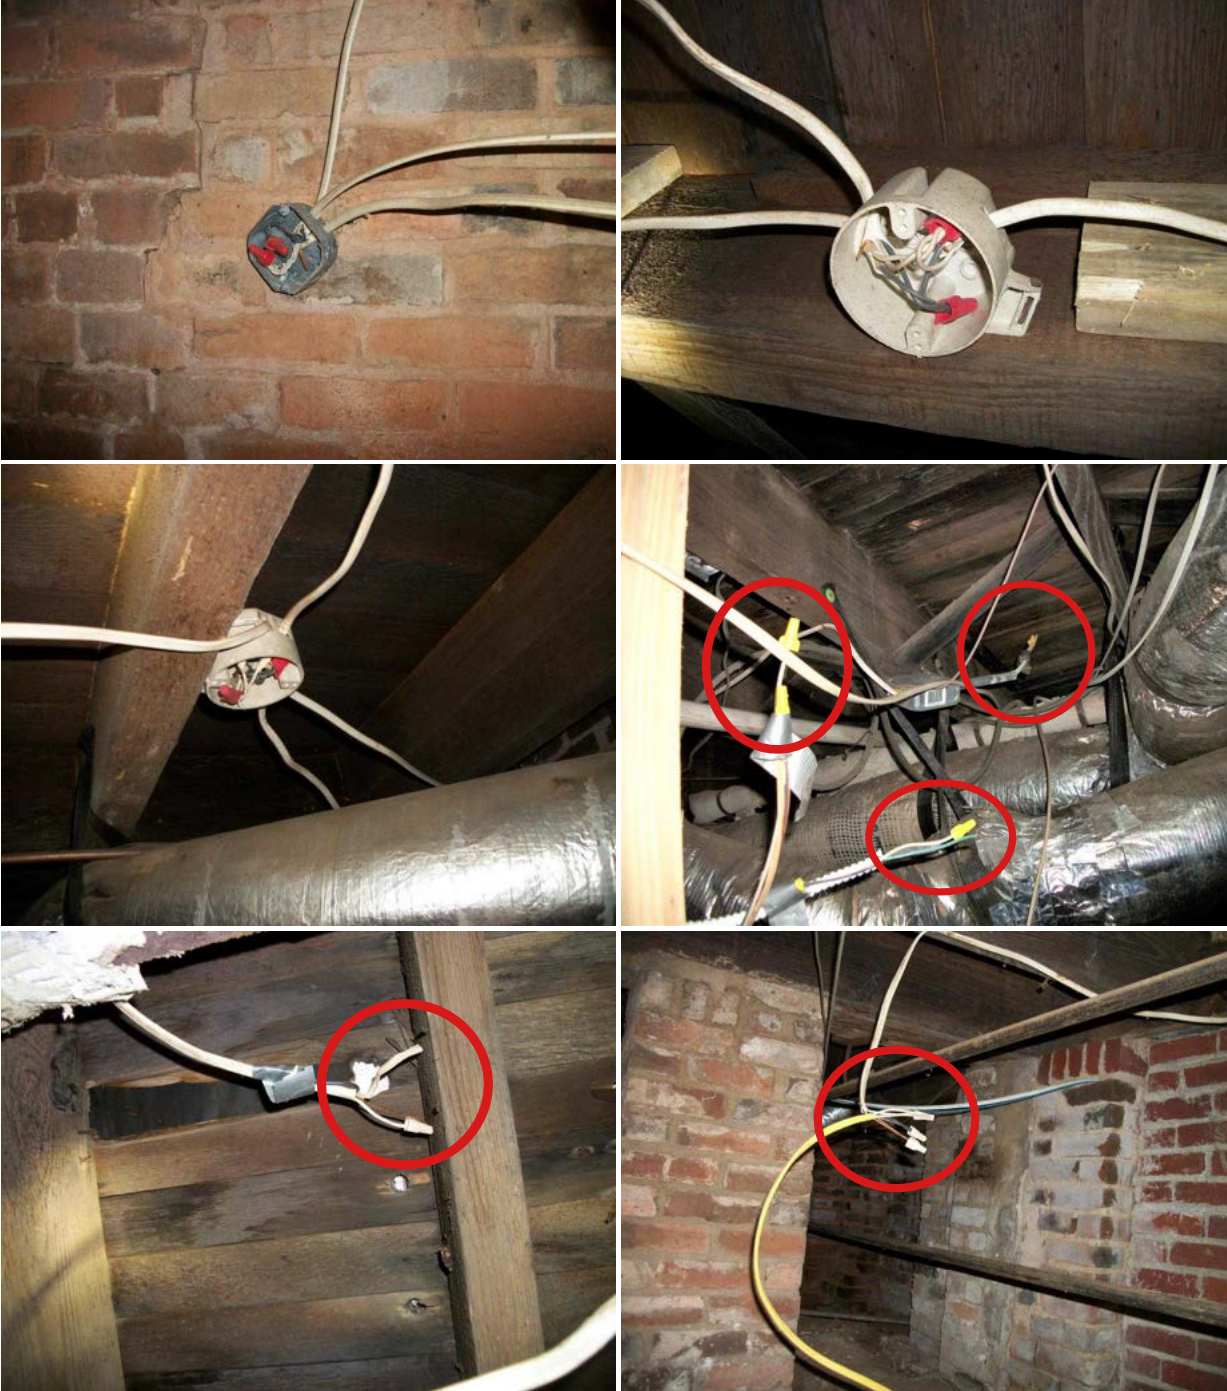
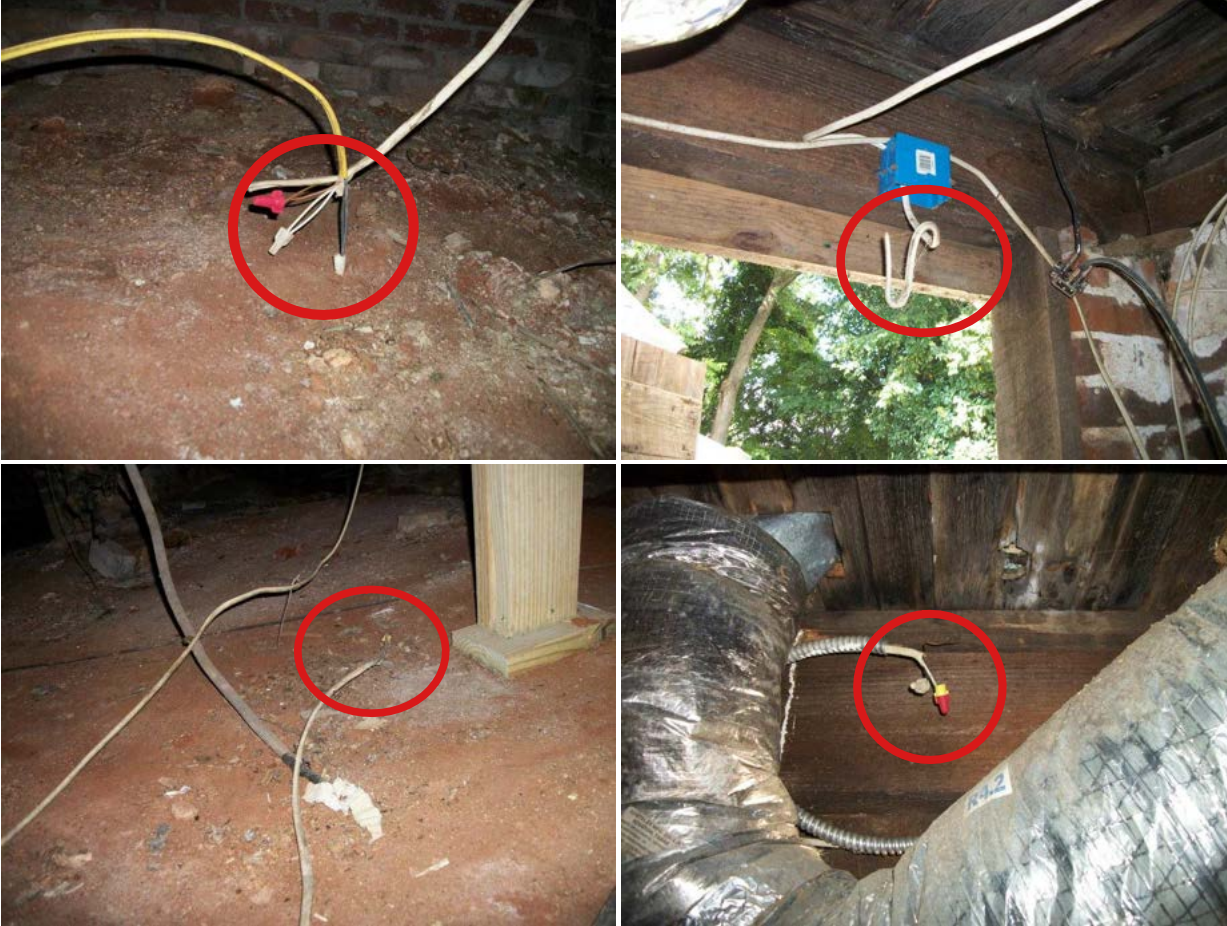
4. Laundry room Electric Panel Wiring - Crawlspace: Copper - Evidence of non-permitted and unsafe electrical work throughout the entire crawl space. Several open junction boxes and loose, unsecured, and improper wire splices throughout....all of which are potential fire and/or contact hazards. (too many to show all...see sampling below) A full circuit evaluation and repair by a licensed electrician is recommended.

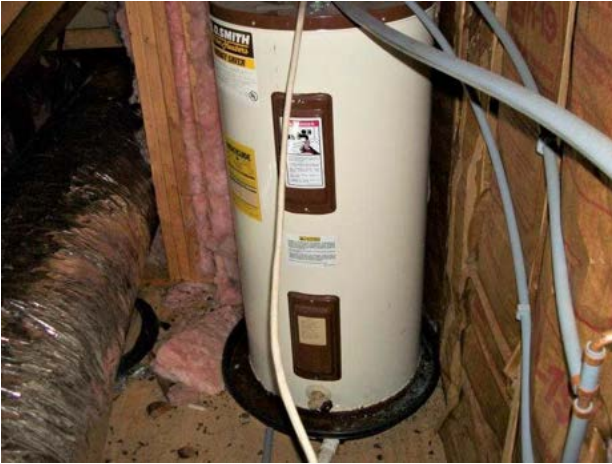
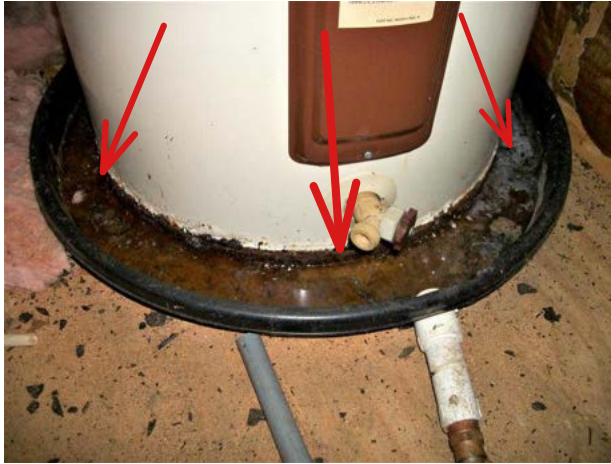
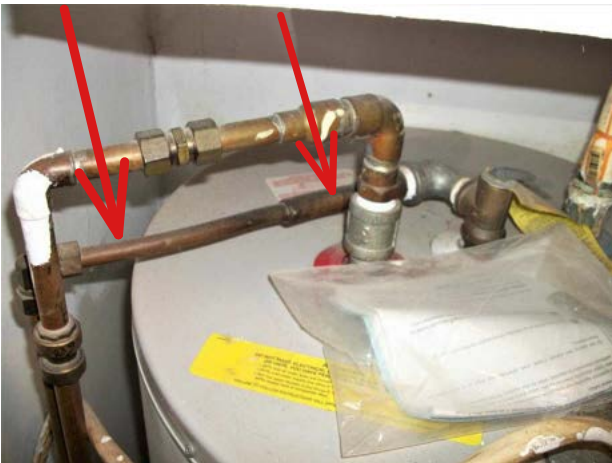
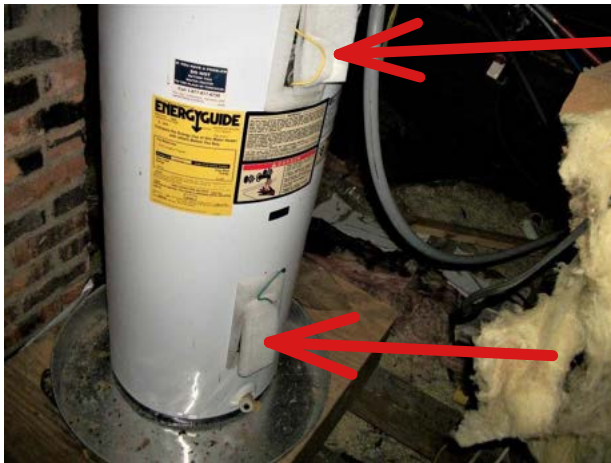
5. Main floor (back hallway & rear bathroom closet), Front & Rear attic. Water Heater Water Heater Operation: **All** water heaters were functional at the time of the inspection (4 total) But there were some issue with a few of them. See below.

\*The oldest unit located in the front attic area was functional at the time of the inspection but appears to be at the end of it's useful life as it has rusted out around the bottom and started to leak...pooling water inside the drip pan at the time of the inspection.

\*The TPRV (Temperature Pressure Relief Valve) at the rear hallway water heater has been improperly plumbed. The TPRV discharge pipe has been reduced down from 3/4" to 1/4" copper tubing. The TPRV is a safety devise and should never be reduced as the size of the discharge pipe must match the opening size of the TPR valve discharge.

\*The protective thermostat cover(s) at the rear attic water heater have been removed...not installed on water heater at the time of the inspection. This leaves an opening to the energized wiring behind the panel cover(s) ...a potential contact hazard. Installing protective cover(s) recommended.

Further evaluation of the above items and repair/correction as needed by a licensed plumbing contractor is recommended.
