## SUMMARY

2934 GA-54, Senoia, GA 30276  
Eric Gleaton  
October 14, 2022

Adrian Brown  
Certified Professional Inspector CPI  
Discovery Inspections, LLC  
678-364-1111  
[discoveryofficemanager@gmail.com](mailto:discoveryofficemanager@gmail.com)

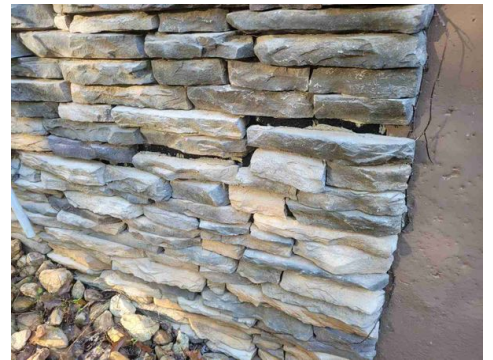
FRONT RIGHT EXTERIOR CORNER

##### **SIDING - LOOSE STONE AND DAMAGED MORTAR**

Loose stone siding and damaged mortar were observed in one or more locations. Recommend this be addressed as needed.

Contact a qualified professional.

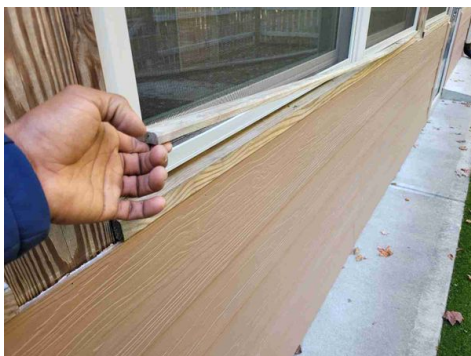
REAR BASEMENT EXTERIOR WALL

##### **TRIM - LOOSE**

Loose trim observed in one or more locations. Recommend this be addressed as needed.

Contact a qualified professional.

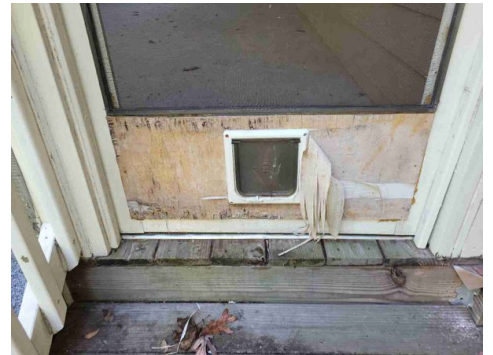
REAR MAIN FLOOR SUNROOM/DECK NEAR EXTERIOR STAIRS

#### DOOR - WOOD DECAY

Wooden exterior door showed signs of damage. Address as needed.

Contact a qualified professional.

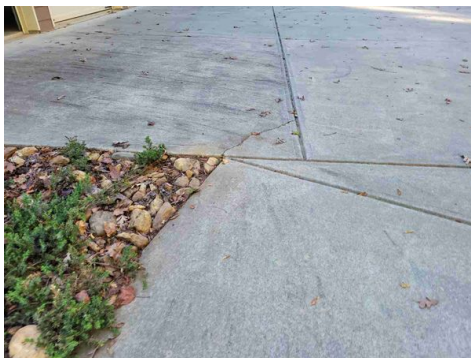
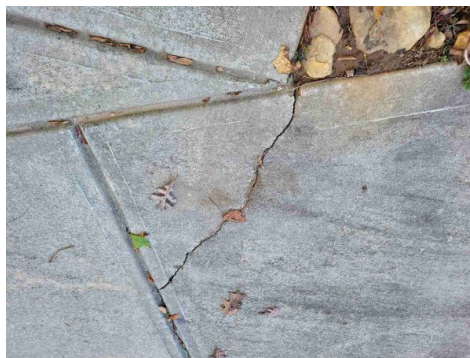
#### WALKWAY - CRACKING (MINOR)

Minor cosmetic cracks observed. Recommend monitor and/or patch/seal.

Contact a qualified professional.

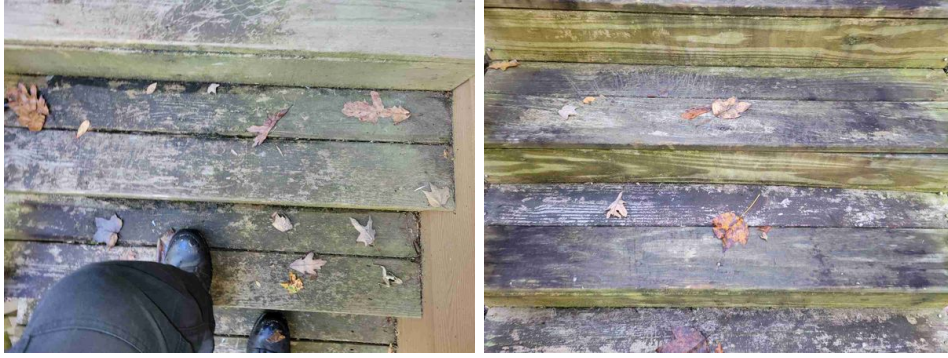
REAR DECK STEPS

#### DECK STEPS - ALGAE GROWTH

Algae growth noted on rear deck steps. Recommend deck Steps be pressure washed as algae is very slippery when wet.

Recommendation  
Contact a handyman or DIY project

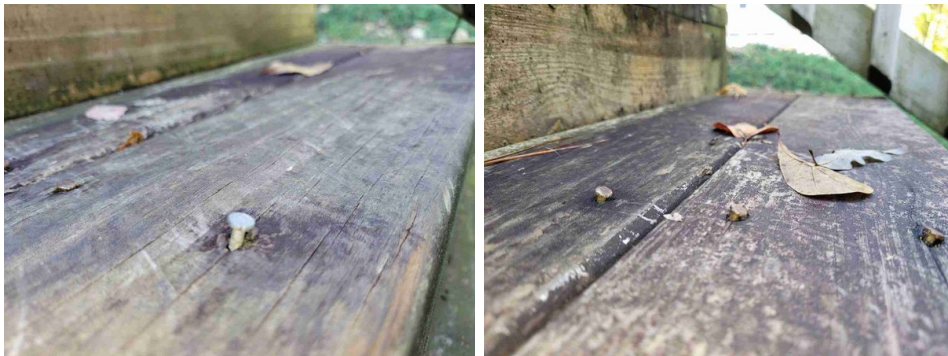
##### DECK STEPS

#### DECK/PORCH - LIFTED NAILS

Raised nails on deck/porch needed to be driven flush to avoid possible injury.

Recommendation  
Contact a handyman or DIY project

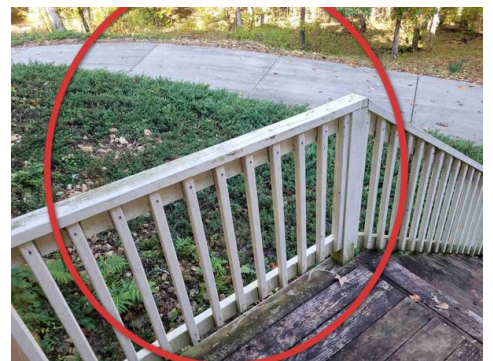
#### DECK/PORCH - RAILING LOOSE

Loose sections of railing for deck/porch needed to be addressed to restore their structural integrity.

Recommendation  
Contact a qualified deck contractor.

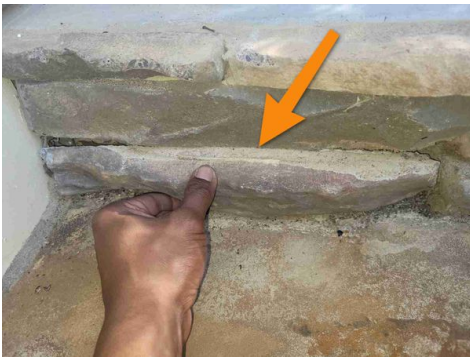
##### TOP STEP

#### PORCH STEPS - MINOR DAMAGE

Minor damage noted on stairs of Porch. Recommend repair as needed.

Recommendation  
Contact a qualified professional.

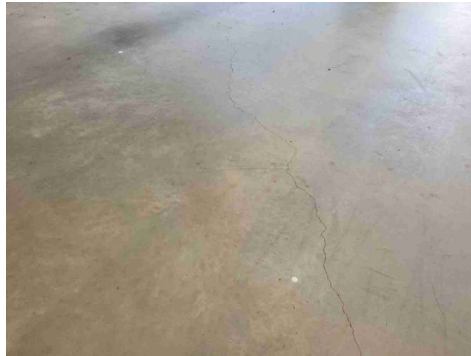
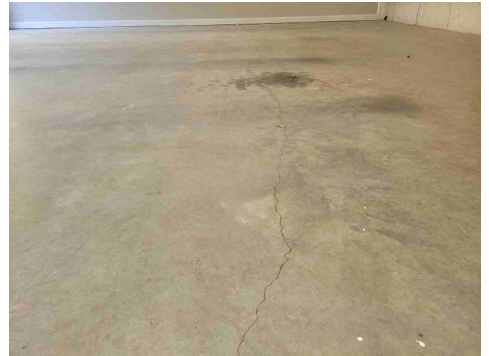
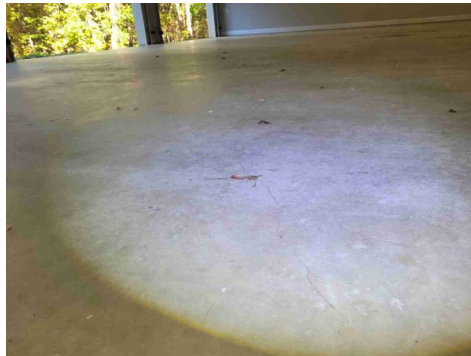
#### GARAGE

### CONCRETE - CRACKING (TYPICAL)

Typical cracks observed in garage slab. They did not appear consequential at the time of the inspection. Seal as necessary.

Contact a qualified professional.

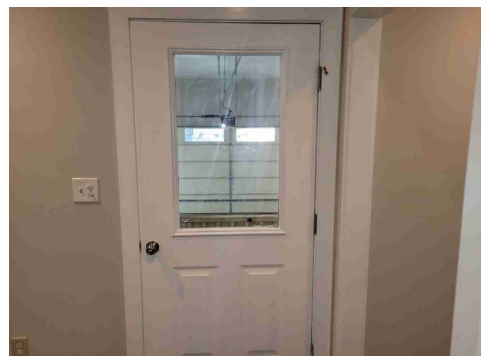
### DOOR - DID NOT MEET SEPARATION REQUIREMENTS

Although, this was acceptable at time of construction, the interior door separating the garage and home does not meet current safety standards. Doors in this type of location (firewalls) must be at least 1 3/8-inch thick, metal/steel, or a 20-minute fire-rated door. Additionally the door was missing weatherstripping. Recommend the door be replaced for fire safety reasons.

Contact a handyman or DIY project

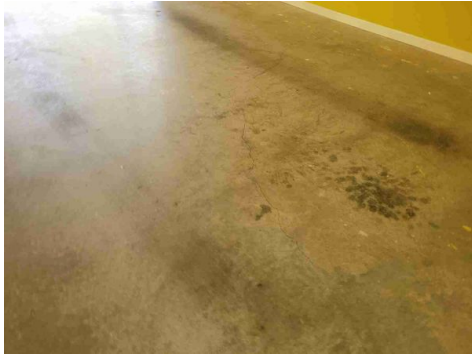
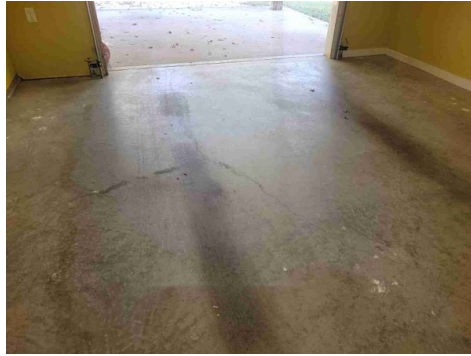
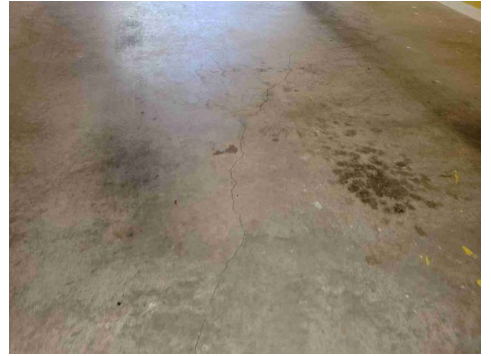
**CONCRETE - CRACKING (TYPICAL)**

Typical cracks observed in garage slab. They did not appear consequential at the time of the inspection. Seal as necessary.

Contact a qualified professional.

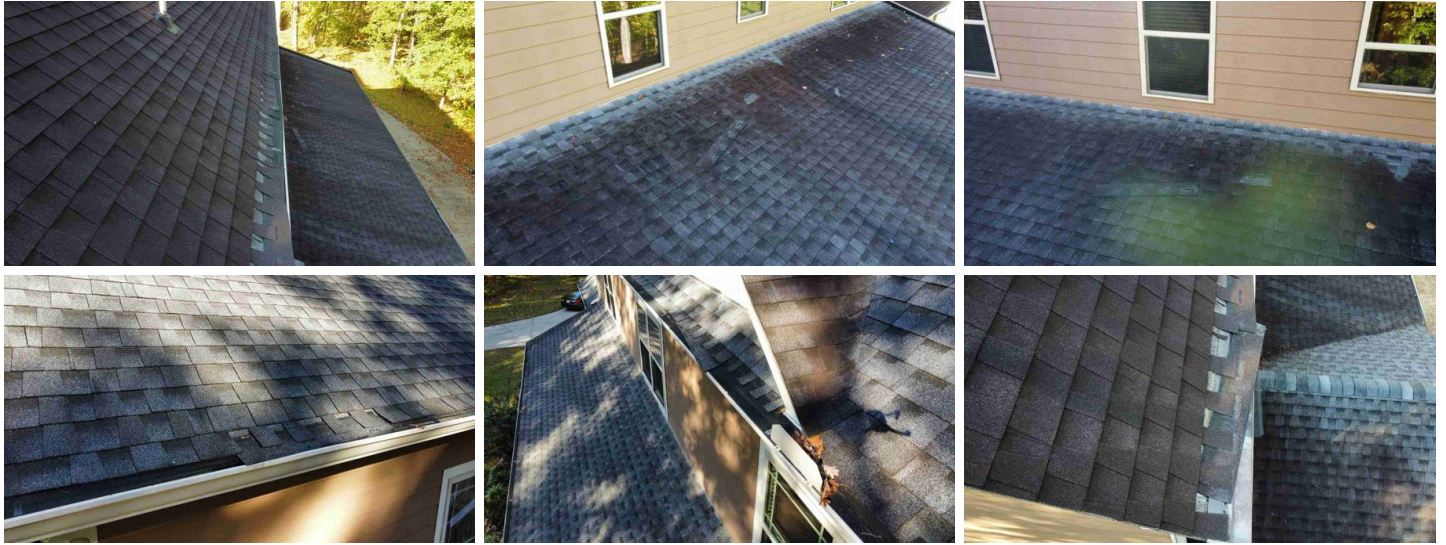
MULTIPLE LOCATIONS ON ROOF

## SHINGLE(S) - LOOSE

One or more shingles on the roof were observed to be loose at time of inspection. Recommend this be addressed as needed.

Contact a qualified roofing professional.

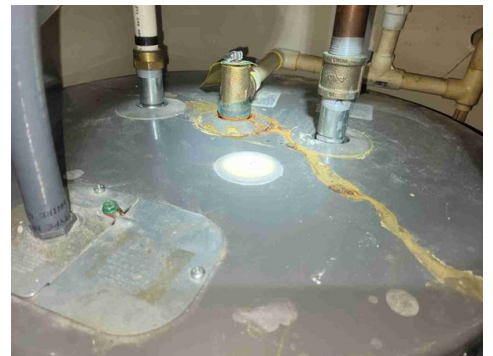
BASEMENT/IN-LAW-SUITE GARAGE

## CORROSION

Corrosion was noted at the burn chamber and/or pipe fittings. Recommend a qualified plumber evaluate for repair/replacement.

Contact a qualified plumbing contractor.

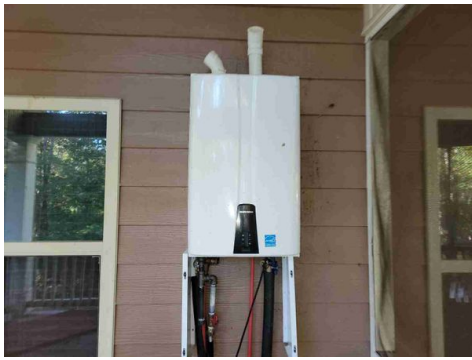
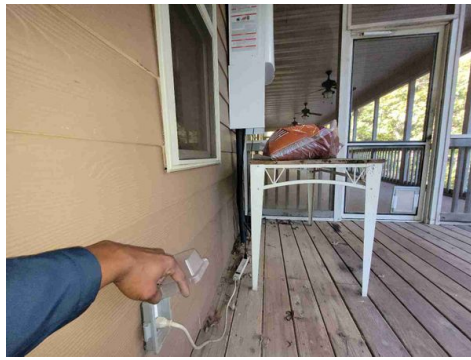
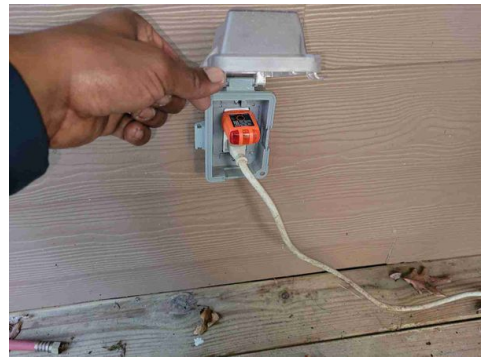
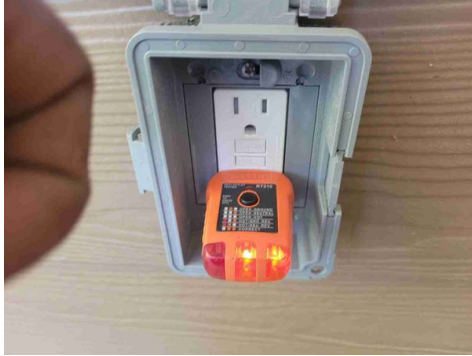
REAR 2ND FLOOR DECK

## TANKLESS WATER HEATER - INOPERABLE

The tankless water heater was not operating at the time of inspection. The inspector attempted to reset the GFCI breaker that powers the unit, which had an extension chord installed. The GFCI tripped when the inspector reset to establish power once the chord was plugged in several times. Recommend a qualified professional contractor address as needed.

Contact a qualified professional.

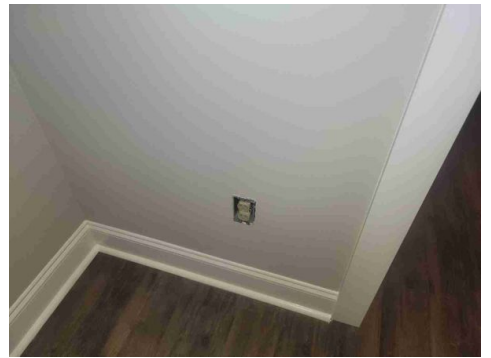
2ND FLOOR REAR RIGHT GUEST BEDROOM

##### **COVER PLATES - MISSING**

One or more receptacles were missing a cover plate. This causes short and shock risk. Recommend installation of plates.

Contact a handyman or DIY project

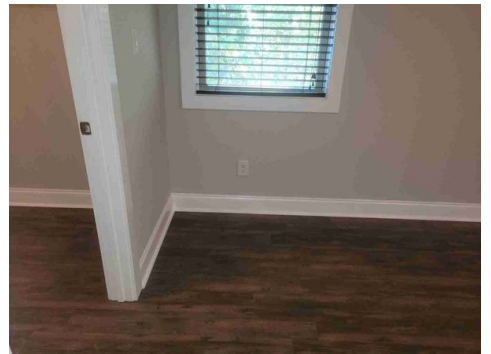
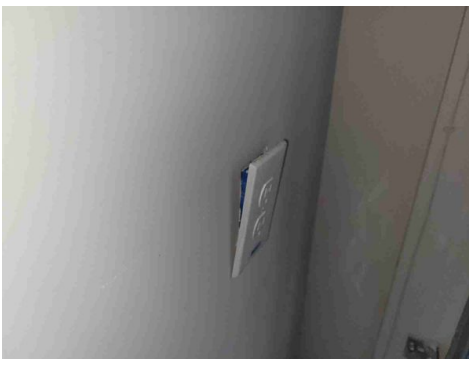
MULTIPLE LOCATIONS IN MULTIPLE ROOMS

##### **ELECTRICAL RECEPTACLE - LOOSE**

Loose electrical outlet should be secured for safety's sake.

Contact a handyman or DIY project

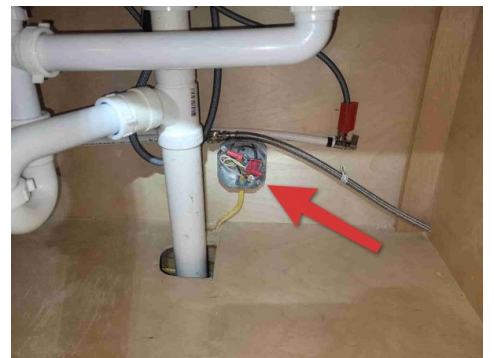
BENEATH IN-LAW-SUITE KITCHEN SINK CABINETRY

##### **JUNCTION BOX - OPEN**

Open junction box needed a cover installed. Address as needed.

Contact a handyman or DIY project

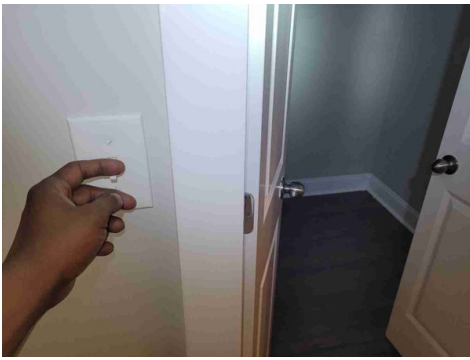
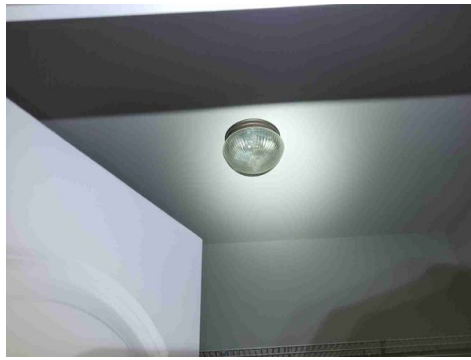
2ND FLOOR REAR GUEST BEDROOM CLOSET

##### **LIGHT(S) - INOPERABLE**

One or more lights were not operating. New light bulb possibly needed.

Contact a handyman or DIY project

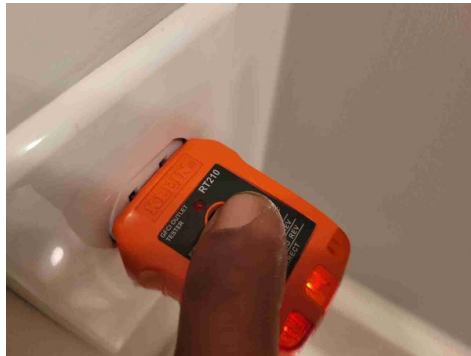
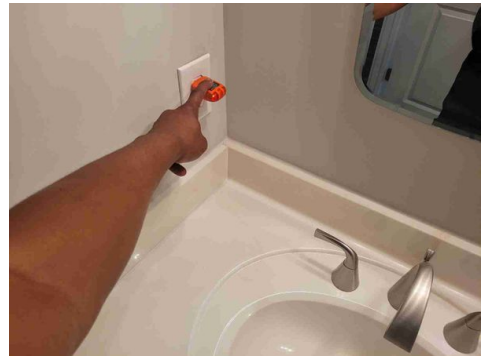
2ND FLOOR GUEST BATHROOM/BASEMENT KITCHEN/EXTERIOR PORCH NEAR WATER HEATER

### GFCI PROTECTION - MISSING/INOPERABLE

GFCI protection was missing or inoperable in one or more required locations at time of inspection. Recommend licensed electrician upgrade by installing ground fault receptacles in all required locations.

Contact a qualified electrical contractor.

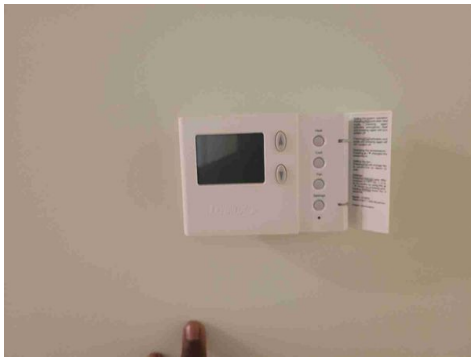
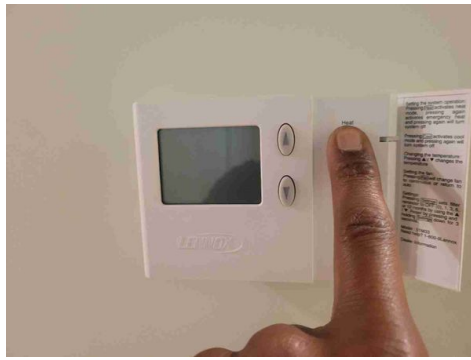
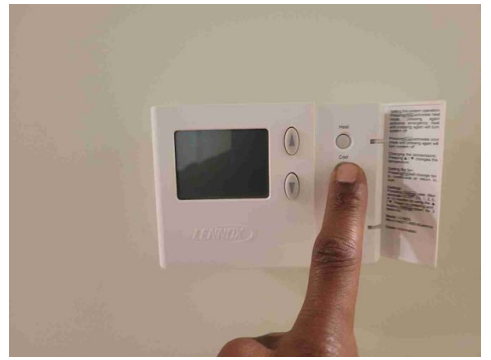
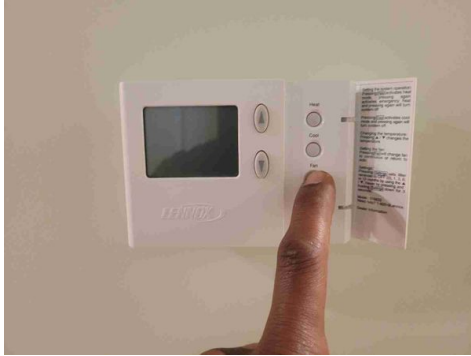
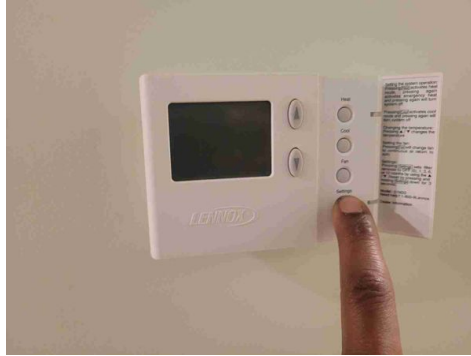
BASEMENT/IN-LAW-SUITE

### THERMOSTAT - INOPERABLE

Thermostat was inoperable. The prevented the HVAC system from being operated. Recommend a qualified contractor evaluate and address as needed for proper operation.

Contact a qualified HVAC professional.

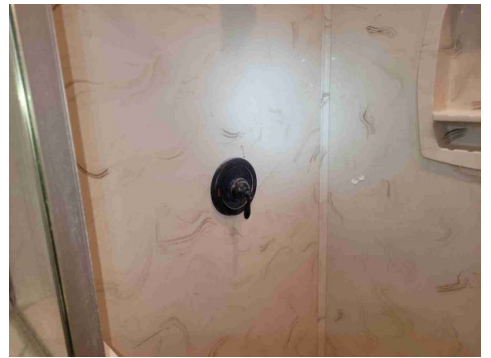
#### 10.6.1 Shower Stall **PLUMBING PIPES - LOOSE**

Loose plumbing pipes noted inside wall at master bath shower stall. Recommend a qualified contractor evaluate and address as needed.

Recommendation  
Contact a qualified professional.

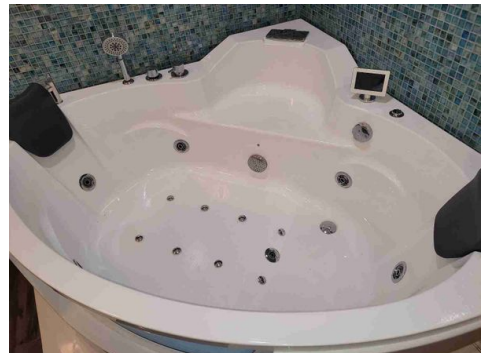
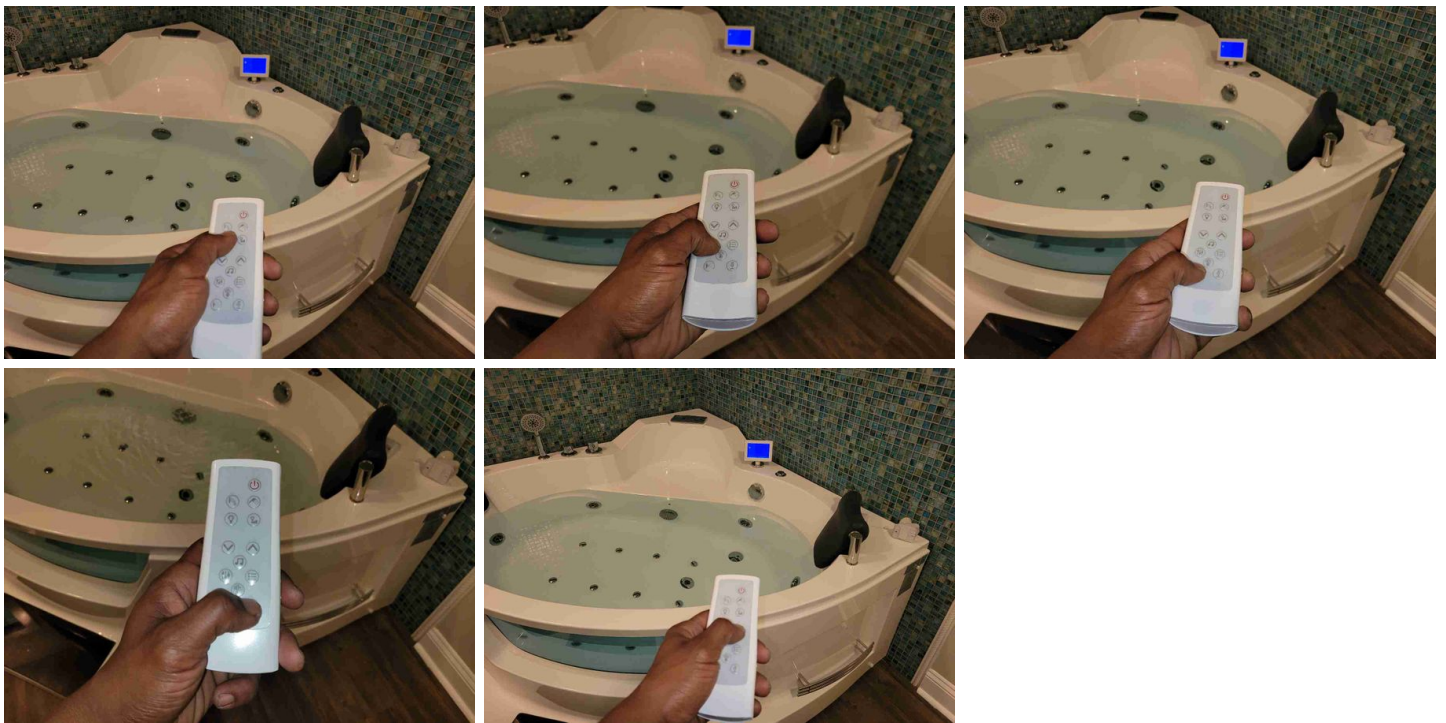
#### 10.7.1 Spa Tub **SPA TUB - INOPERABLE**

Master spa tub was filled with water and did not operate. Recommend a qualified contractor evaluate and address as needed.

Recommendation  
Contact a qualified professional.

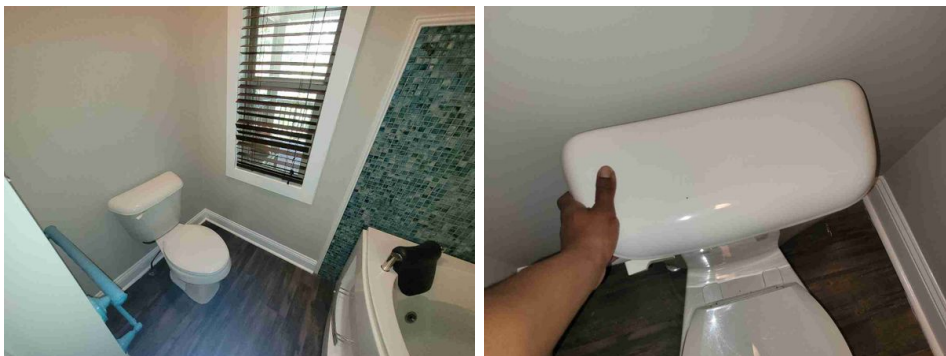
### TOILET TANK - LOOSE

Toilet tank was loose and should be addressed to prevent leaks and potential damage.

Contact a qualified plumbing contractor.

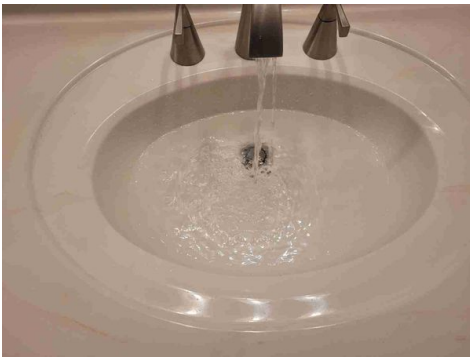
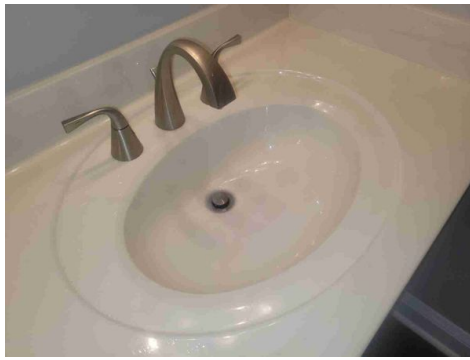
RIGHT SIDE SINK OF IN 2ND FLOOR GUEST BATHROOM

### DRAIN STOP - DID NOT SEAL COMPLETELY

Drain stop operated but did not seal completely or took longer than normal to fill. This allowed water to bypass the drain stop. Address as needed for proper operation.

Contact a handyman or DIY project

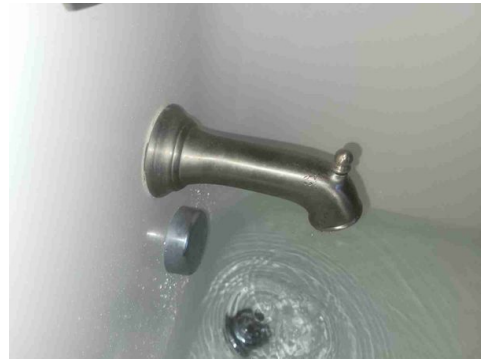
2ND FLOOR GUEST BATHROOM

11.6.1 Tub/Shower  
**TUB SPOUT - LOOSE**

Loose tub spout observed in the guest bath tub/shower. Address as needed.

Recommendation  
Contact a qualified professional.

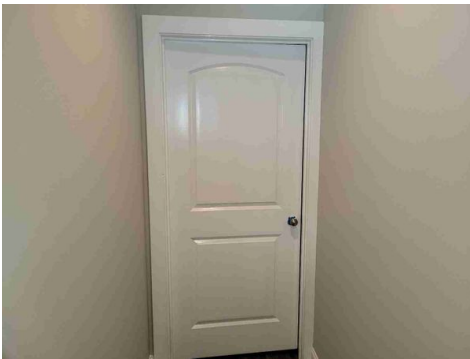
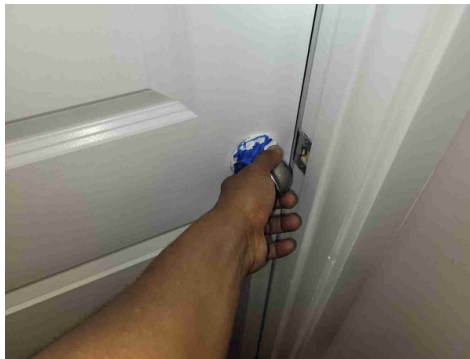
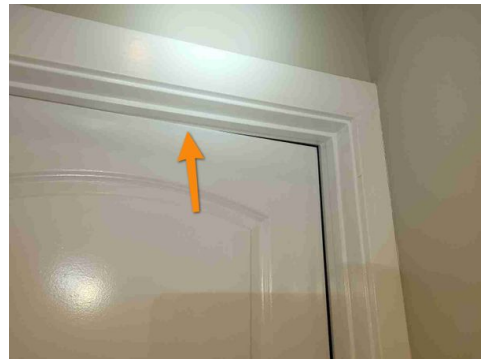
1ST FLOOR MUD ROOM/CLOSET NEAR GARAGE

12.1.1 Doors  
**DOOR - CONFLICTED WITH JAMB**

Recommend minor adjustment to door. Door conflicts with its jamb.

Recommendation  
Contact a qualified professional.

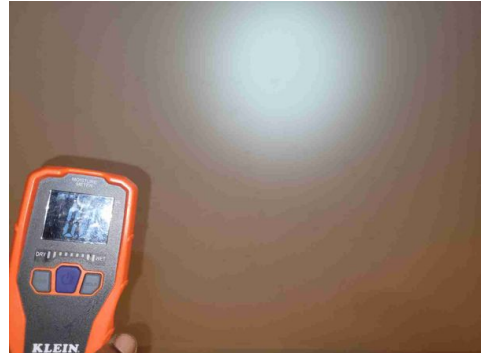
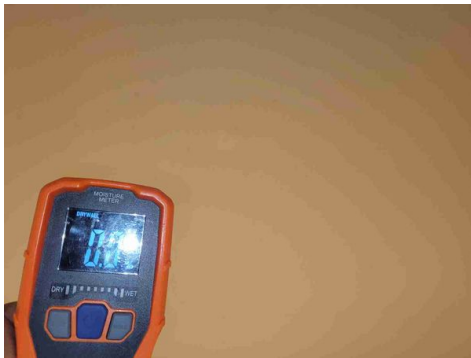
CEILING NEAR GARAGE/BASEMENT GUEST BATHROOM

**DISCOLORATION/STAIN(S) - DRY**

One or more areas of discoloration/staining observed on the ceiling were tested with an electronic moisture meter and were found to be dry at the time of the inspection. The client is encouraged to monitor this location and address as needed. Client may wish to paint these areas.

Recommend monitoring.

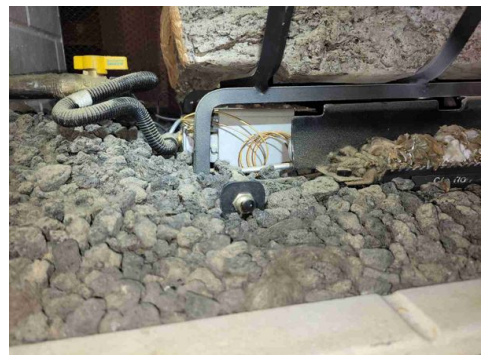
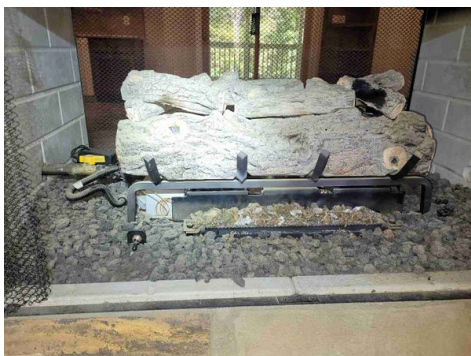
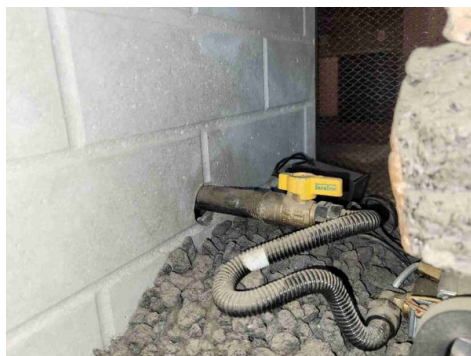
**GAS LOGS - DID NOT OPERATE**

The fireplace did not operate when turned on by switch/remote. Recommend inquiring with seller.

Contact the seller for more info

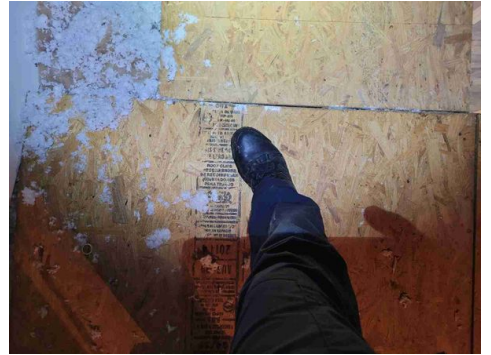
GARAGE ATTIC/NEAR ACCESS TO LEFT SIDE IN MAIN ATTIC

### SERVICE PLATFORM - UNSTABLE/INCONSISTENT

The wood flooring in front of the attic air handler was inconsistent and unstable. Recommend it be addressed to provide a safe working platform.

Contact a qualified professional.

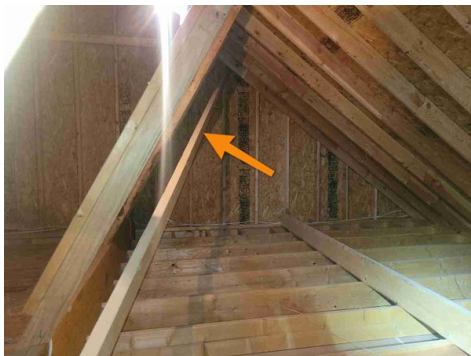
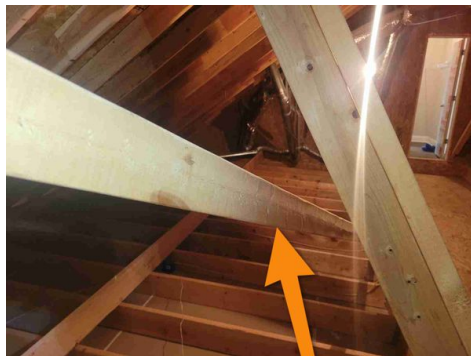
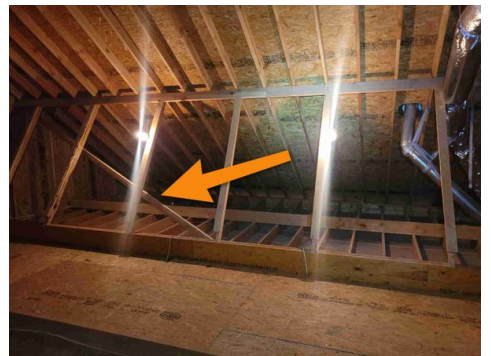
RIGHT SIDE FROM DOOR IN ATTIC GARAGE

### BRACING - LOOSE

Loose bracing noted in the attic. Recommend repairs for structural support.

Contact a qualified professional.

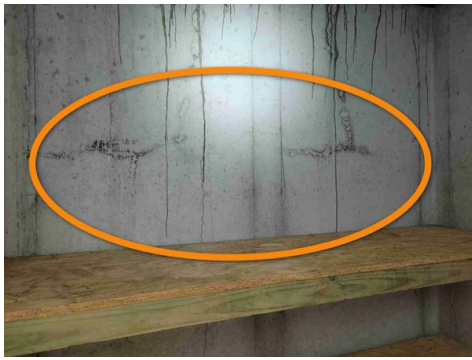
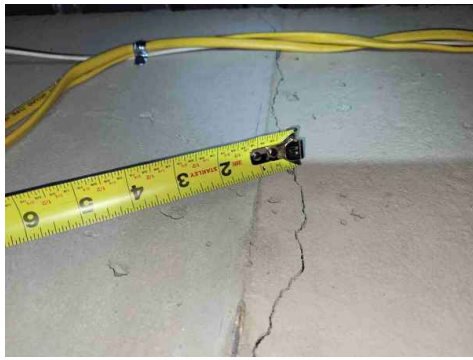
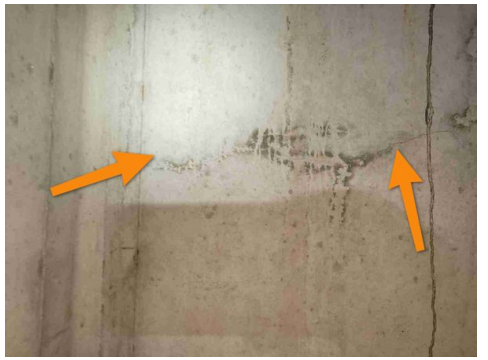
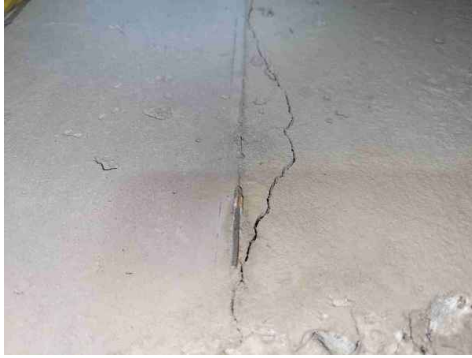
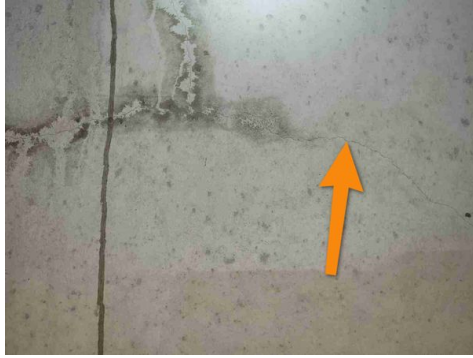
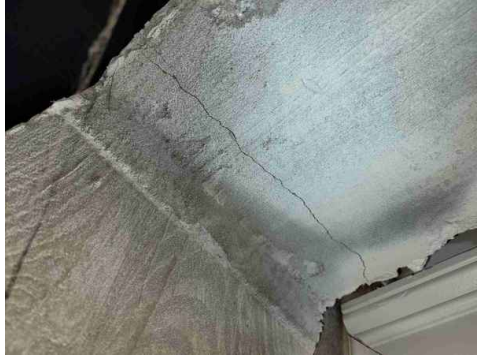
STORM ROOM/SAFE ROOM

### FOUNDATION CRACK(S) - MINOR

Minor cracking was noted at the foundation. This is common as concrete ages and shrinkage surface cracks are normal. Recommend monitoring for more serious shifting/displacement.

Contact a qualified professional.

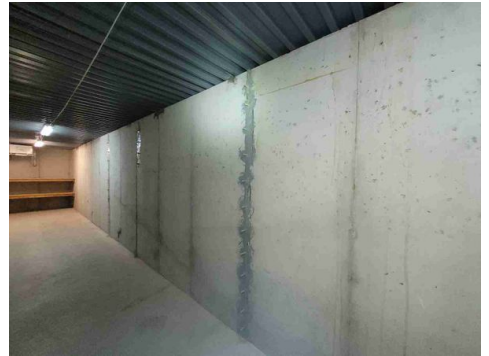
##### SEVERAL AREAS IN STORM SHELTER/SAFE ROOM

#### **FOUNDATION - PRIOR REPAIR(S)**

Prior foundation injection repair(s) observed in the basement. Repairs appeared satisfactory. These types of repairs often have warranties. Inquire with the seller about any supporting documentation.

Contact the seller for more info
