Home Inspection Report

116 Augusta Drive Peachtree City, GA 30067

Date of Inspection: 09/30/2019

Inspection No. 201151-327

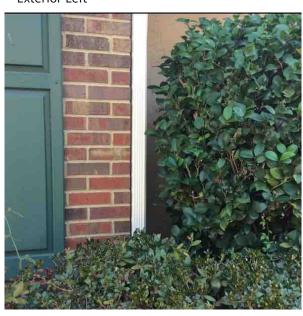
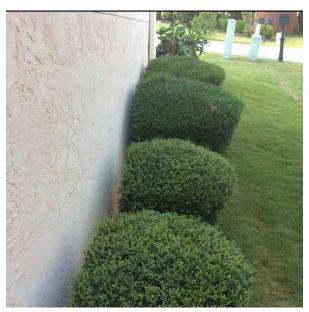
- 1.1.1 Trim and maintain trees, bushes and vines away from the structure to minimize damage/wear to structure and to discourage animal activity.
- Exterior Front
- Exterior Left

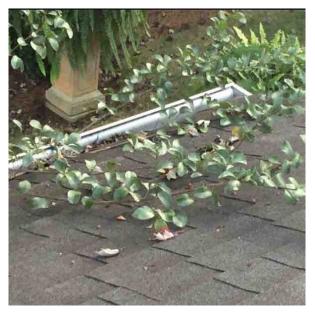
1.1.2 Trim and maintain trees, bushes and vines away from the structure to minimize damage/wear to structure and to discourage animal activity. (Exterior Left)

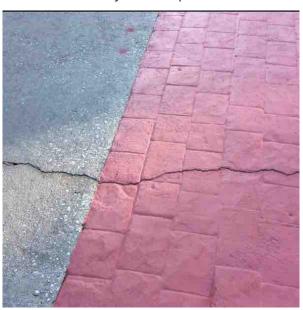
1.2.1 Seal driveway cracks to prevent moisture and water from widening the cracks. (Exterior Front)

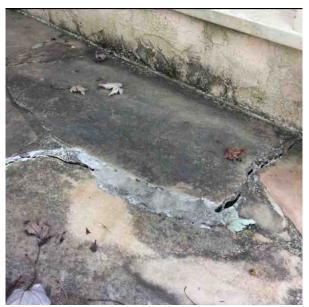
1.3.1 Patio is uneven in areas and is a trip hazard. This should be evaluated and corrected for safety. **(Exterior Back)**

1.3.1 Patio is uneven in areas and is a trip hazard. This should be evaluated and corrected for safety. (Exterior Back)

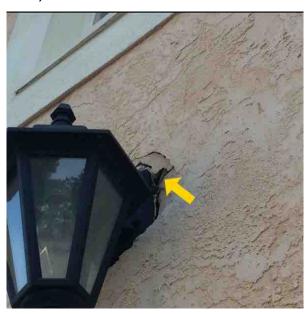
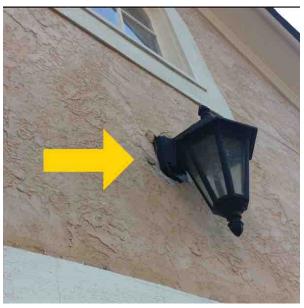
- Stucco over masonry
- 2.1.1 The wall surface is damaged. Repairs are required to prevent deterioration and to maintain integrity.

Open penetrations noted in wall surface. Seal to prevent the intrusion of moisture and pests. **(Exterior Front)**

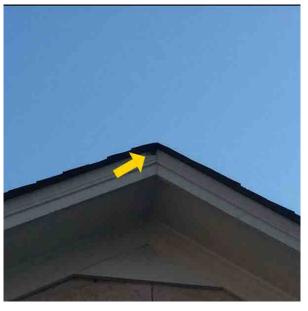
2.2.1 Sections of fascia/soffit are damaged. Secure fascia and soffit and seal all gaps to help prevent further damage and unwanted pest entry. **(Exterior Front)**

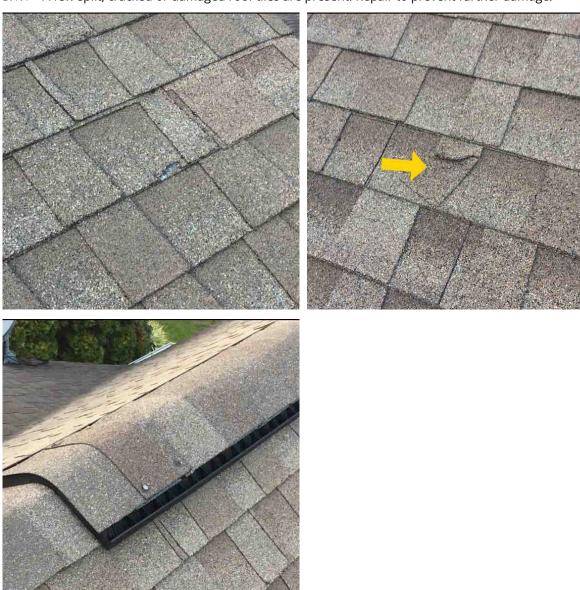
- Asphalt shingles
- 3.1.1 A few split, cracked or damaged roof tiles are present. Repair to prevent further damage.

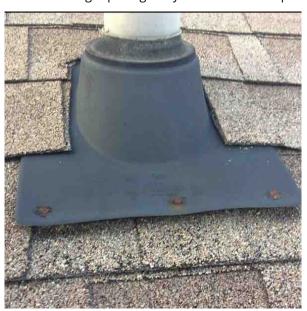
3.1.2 Flashing is pulling away from the roof. Repair to prevent further damages.

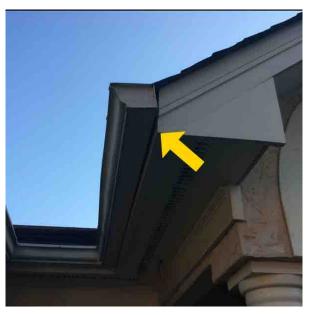
3.2.1 Gutter has started to separate from fascia. Secure loose gutters to fascia for proper drainage off roof. (Exterior Front)

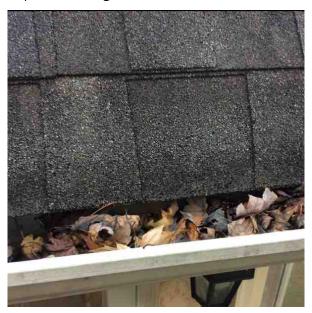
3.2.2 Gutters are full of leaves and debris. Clean and remove debris from gutters for proper drainage off roof. This is an ongoing maintenance requirement that should be completed twice a year or as required. (Throughout)

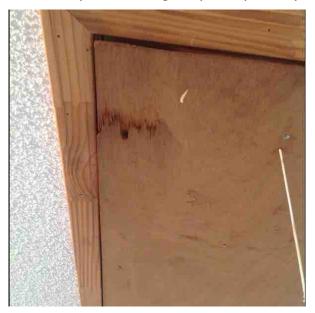
4.1.1 Attic panel is damaged repair/ replace to prevent further damage. (Garage)

- Pulldown Ladder
- 4.1.1 Attic panel is damaged repair/ replace to prevent further damage. (Garage)

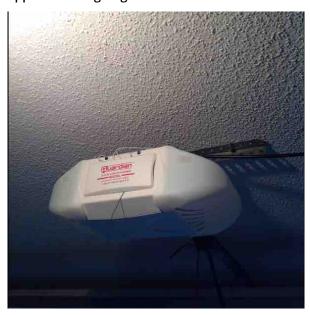
5.1.1 Repair reversing switch for garage door. The garage door doesn't reverse when pressure is applied under garage door this needs to be corrected for safety. (**Garage**)

5.1.1 Repair reversing switch for garage door. The garage door doesn't reverse when pressure is applied under garage door this needs to be corrected for safety. (Garage)

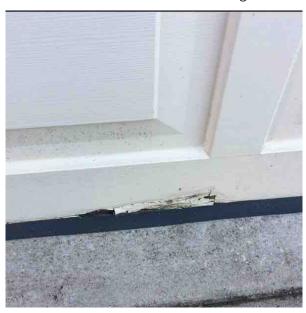
5.1.2 The door has some wood rot along the bottom. Repair to prevent further damage.

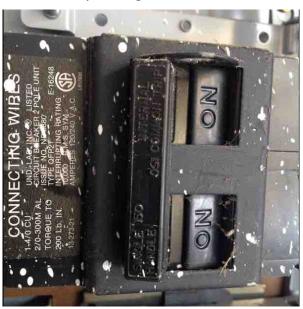
⊙ The main electrical disconnect is in the garage.

7.1.1 **150** amps (Garage)

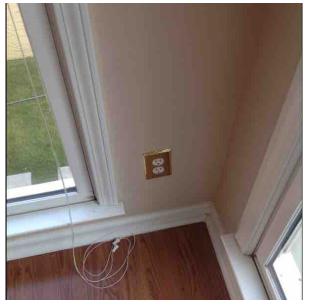
7.2.1 Loose receptacles should be secured to prevent electric shock injuries.

- Family room
- Hallway Bathroom
- Master Bedroom
- sun room

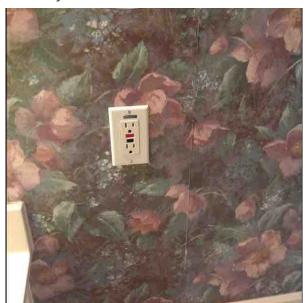
- 7.2.2 Loose receptacles should be secured to prevent electric shock injuries.
- · Master Bathroom
- Hallway Bathroom

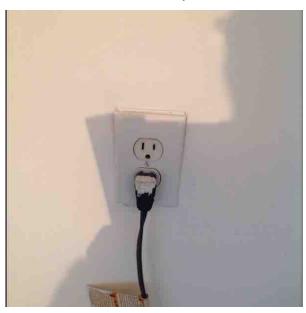
7.2.3 Outlet is not on a GFCI protected circuit. This needs to be corrected for safety. (Garage)

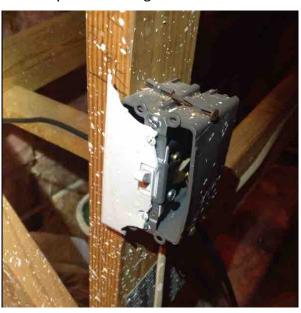
7.3.2 Replace broken light switch cover for electrical safety. (Attic)

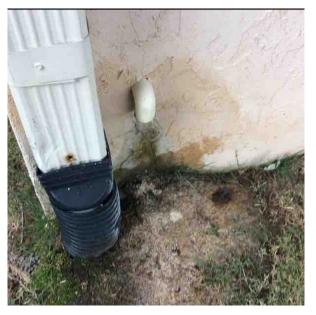
8.1.1 Air conditioner condensation drain line is draining next to the house. Extend the drain 5 feet from the house to prevent water damage to the foundation.

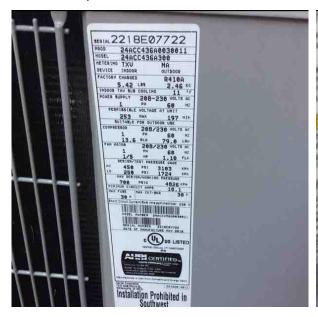
- Air Conditioning System
- 8.2.1 Carrier ac unit, 2018, 2 ton

Noted water present under the unit. Have this checked by licensed HVAC technician. (Exterior Right)

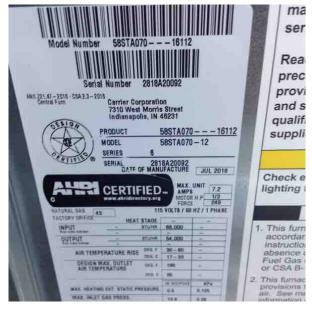
8.3.1 Seal air leaks for maximum efficiency.

2018 Carrier furnace.

The air conditioner worked fine throughout the house. (Attic)

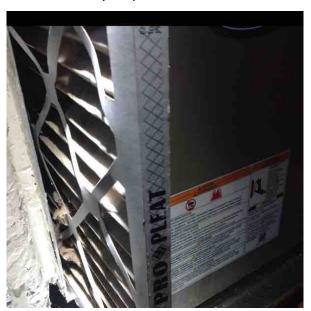
8.4.1 Filter is dirty. Replacement is needed.

Size: 16 x 25 x 1 (Attic)

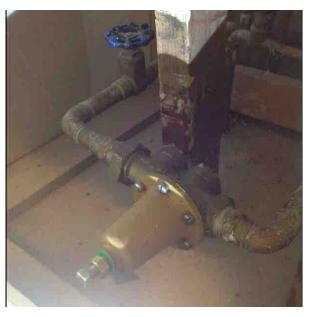
- 9.1.1 Inspected the visible portion of the house water main.
- 9.1.2 Main water shut off valve for the whole house and water pressure regulator. (Laundry area)

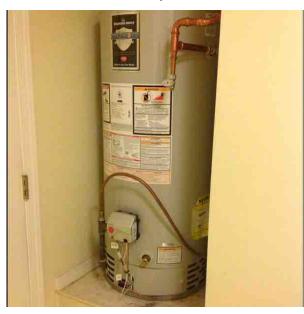
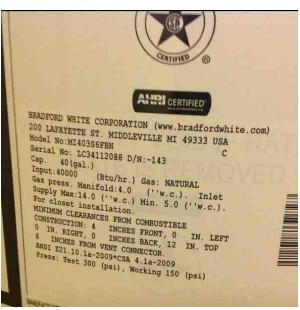
9.2.2 Bradford and White water heater.

Install a drain pan under the water heater to prevent water leaks that might occur not to overflow within the house. (Laundry area)

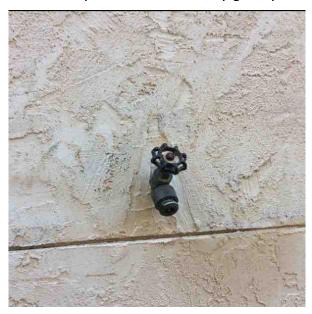
9.3.1 Hose Bibb faucet is not working. Repair for proper operation.

Install anti siphon device on water spigot to prevent possible contamination. (Exterior Left)

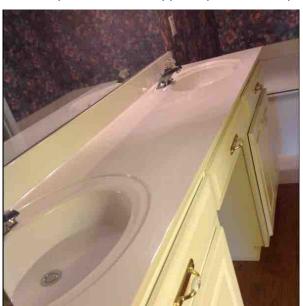
9.4.1 Repair both sink stoppers operations for proper functionality. (Master Bathroom)

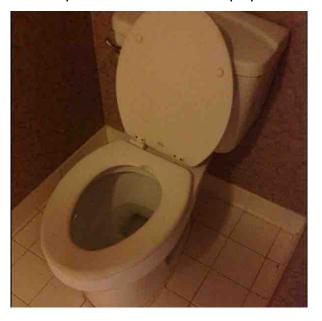
9.5.1 Replace broken toilet seat for proper functionality. (Master Bathroom)

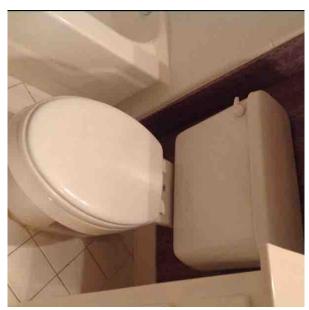
9.5.2 Toilet water at toilet runs continuously. Hardware repair or replacement is needed. (Hallway Bathroom)

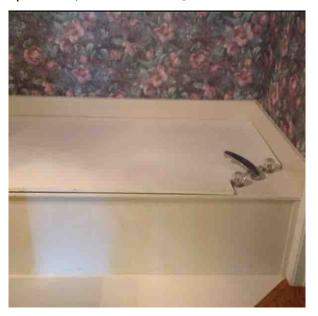
9.6.1 Tub has a plywood cover over it. Unable to remove to test tub. Remove and test tub for proper operation. (Master Bathroom)

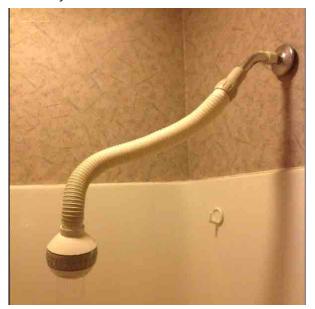
9.6.2 Shower head hose is leaking at both connections repair as needed for proper functionality.

- Master Bathroom
- Hallway Bathroom

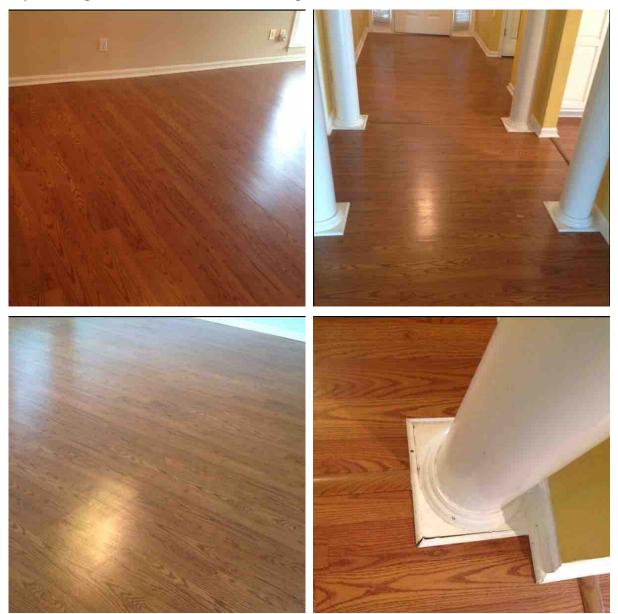
10.1.1 Floor is weak and /or loose, uneven, in several areas throughout the house repair to prevent further damage and for trip hazard safety.

Repair damaged column base as needed. (Throughout)

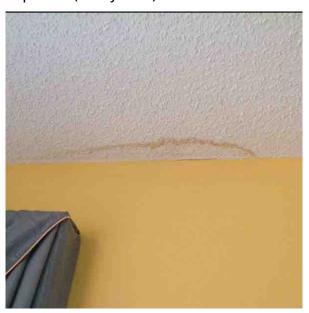
10.2.1 Previous Water stains and / or repair work was noted on ceiling tested dry at the time of the inspection. (Family room)

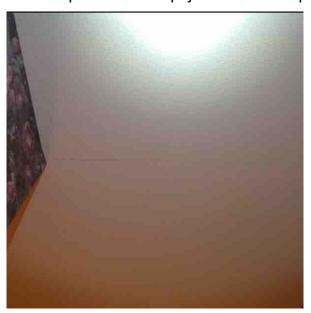
10.2.2 Repair Sheetrock tape joint as needed to prevent further damage. (Master Bathroom)

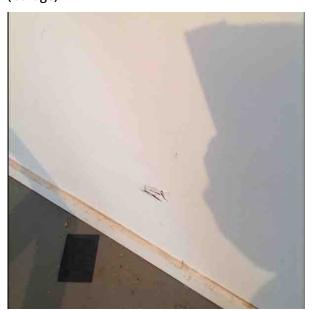
10.2.3 Opening noted in wall. Repair to maintain a fire barrier and to prevent poisonous gases from entering the house. These need to be repaired to prevent the intrusion of moisture and pests. (Garage)

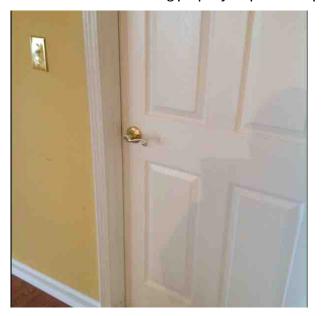
10.3.1 Door is not latching properly. Repair for improved functionality. (Master Bedroom)

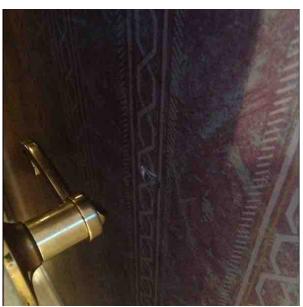
10.3.2 Door stop is needed and or missing. Install one to prevent damage to wall and or base board.

- · Hallway Bathroom
- Entrance Door

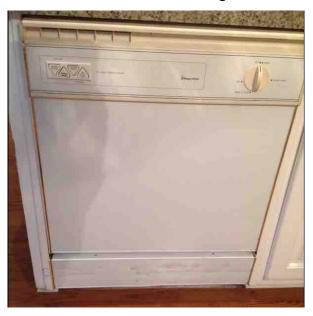
11.1.1 The dishwasher was working at the time of the inspection. (Kitchen)

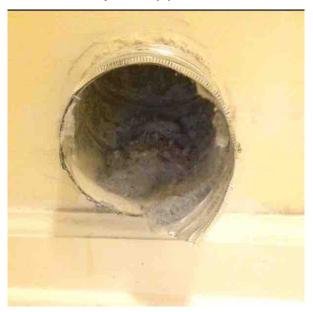
11.2.1 Clean dryer vent pipe and lint screen for fire safety and maximum efficiency. (Laundry area)
