## SUMMARY

2934 GA-54, Senoia, GA 30276  
Eric Gleaton  
October 14, 2022

Adrian Brown  
Certified Professional Inspector CPI  
Discovery Inspections, LLC  
678-364-1111  
[discoveryofficemanager@gmail.com](mailto:discoveryofficemanager@gmail.com)

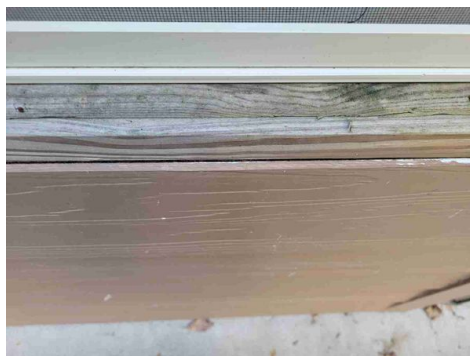
REAR BASEMENT EXTERIOR WALL

##### **TRIM - LOOSE**

Loose trim observed in one or more locations. Recommend this be addressed as needed.

Contact a qualified professional.

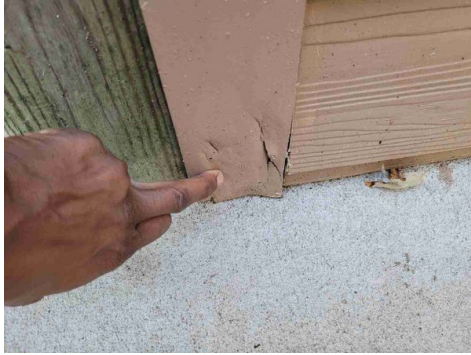
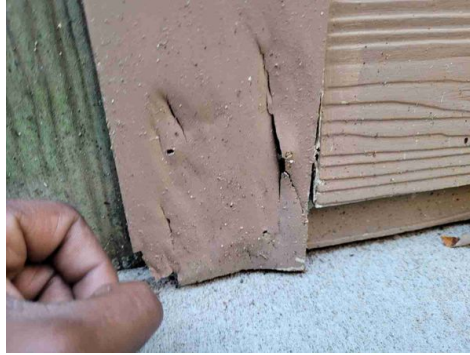
REAR RIGHT EDGE OF BASEMENT SUNROOM

#### TRIM - WOOD DECAY

Recommend a qualified contractor address minor wood decay at trim.

Contact a qualified professional.

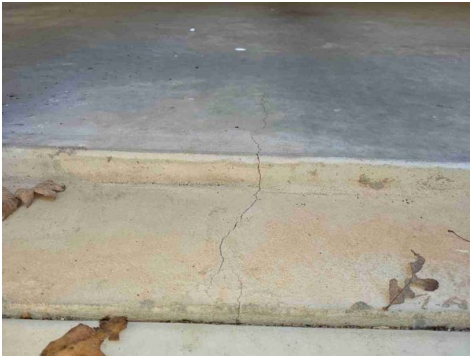
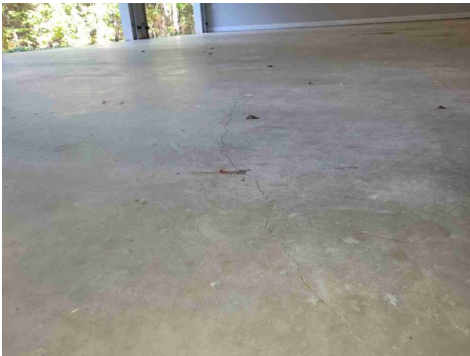
### CONCRETE - CRACKING (TYPICAL)

Typical cracks observed in garage slab. They did not appear consequential at the time of the inspection. Seal as necessary.

Contact a qualified professional.

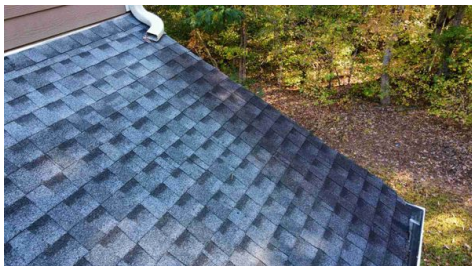
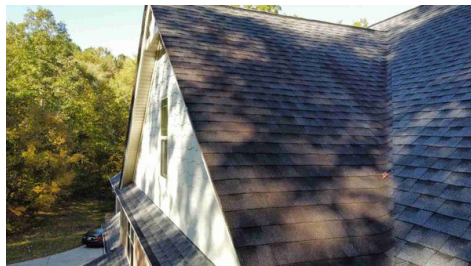
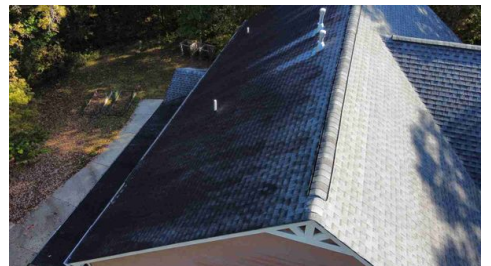
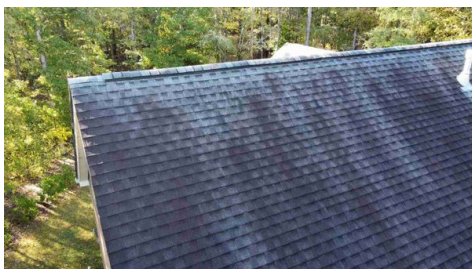
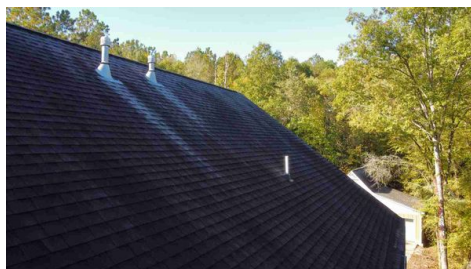
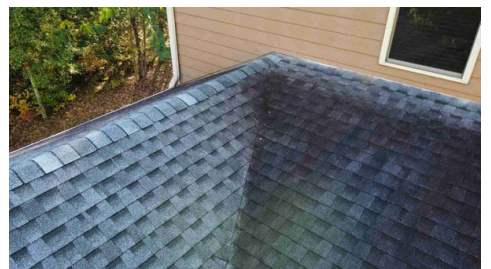
Roof shingles were discolored, which can be caused by moisture, rust or soot. Recommend a qualified roofing contractor evaluate and remedy with a roof cleaning or repair.

Contact a qualified roofing professional.

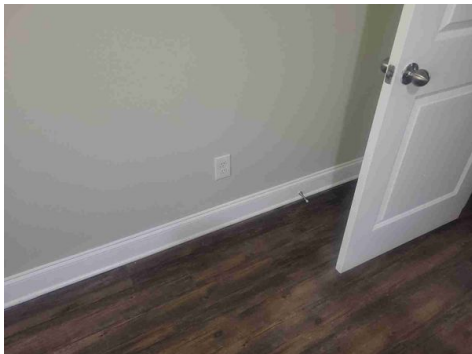
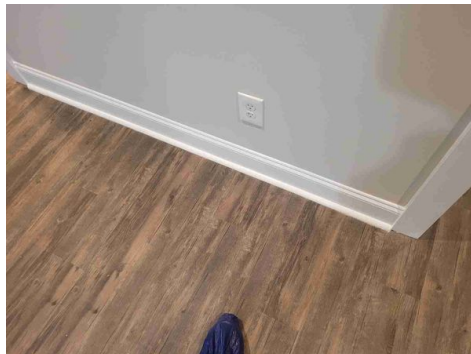
##### **ELECTRICAL RECEPTACLE - LOOSE**

Loose electrical outlet should be secured for safety's sake.

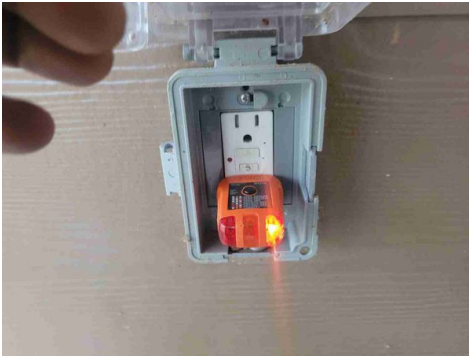
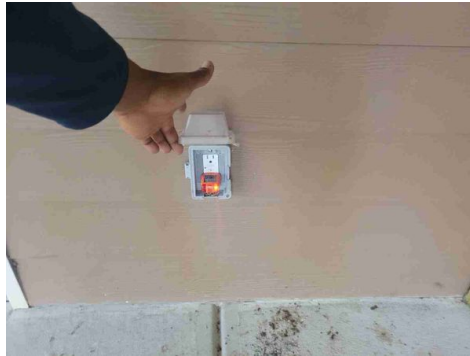
One or more electrical receptacle(s) had an open neutral. Recommend a qualified contractor evaluate and address as needed for safety's sake.

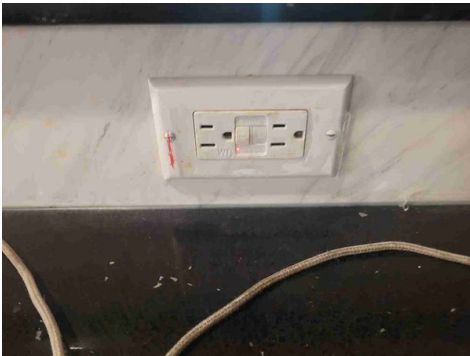
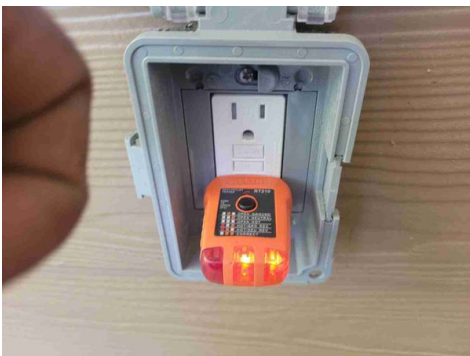
### GFCI PROTECTION - MISSING/INOPERABLE

GFCI protection was missing or inoperable in one or more required locations at time of inspection. Recommend licensed electrician upgrade by installing ground fault receptacles in all required locations.

Contact a qualified electrical contractor.

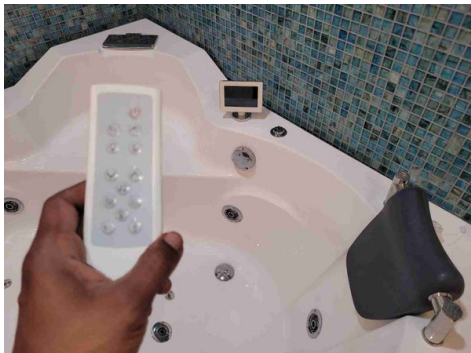
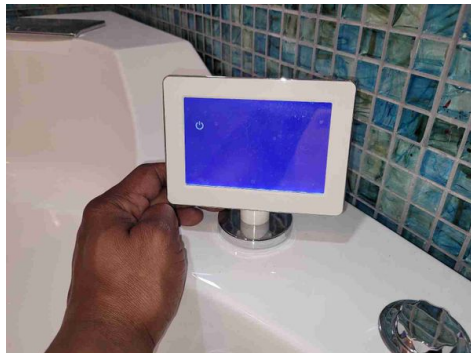
Master spa tub was filled with water and did not operate. Recommend a qualified contractor evaluate and address as needed.

Recommendation  
Contact a qualified professional.

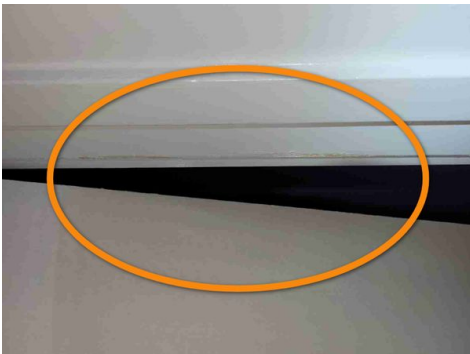
Recommend minor adjustment to door. Door conflicts with its jamb.

Recommendation  
Contact a qualified professional.

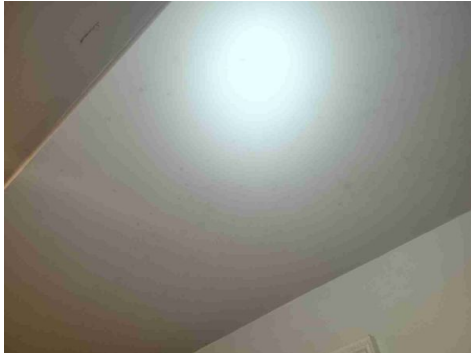
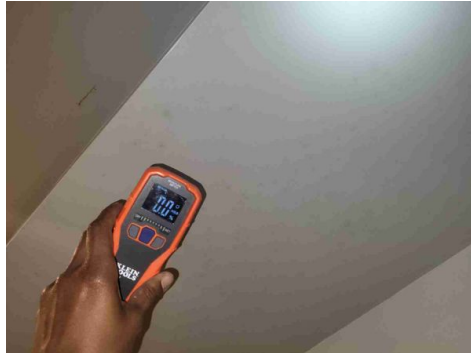
CEILING NEAR GARAGE/BASEMENT GUEST BATHROOM

**DISCOLORATION/STAIN(S) - DRY**

Recommend monitoring.

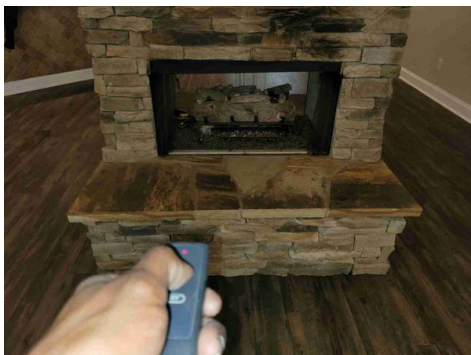
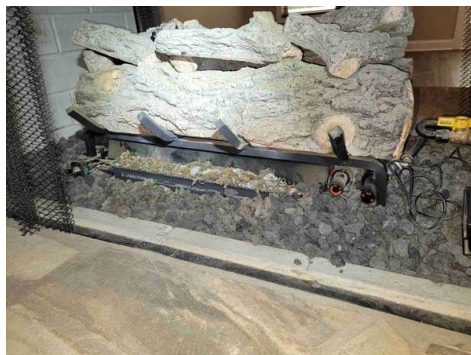
**GAS LOGS - DID NOT OPERATE**

Contact the seller for more info

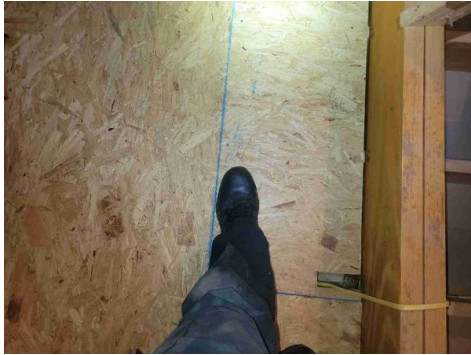
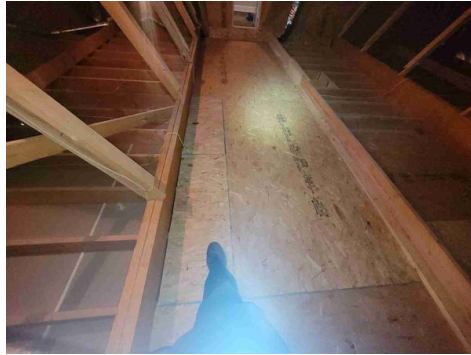
### SERVICE PLATFORM - UNSTABLE/INCONSISTENT

Contact a qualified professional.

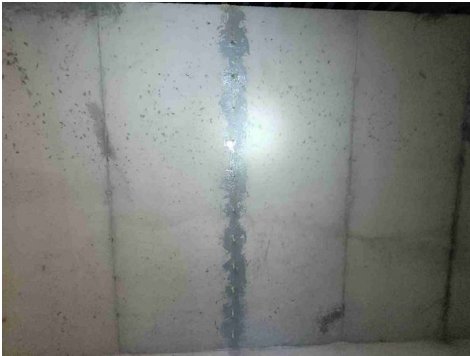
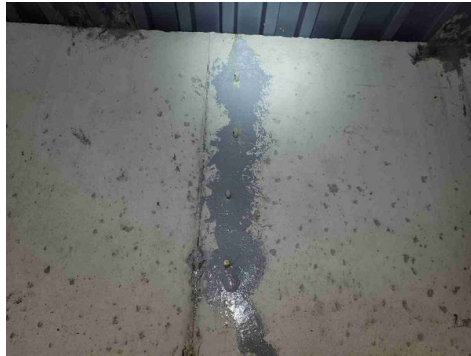
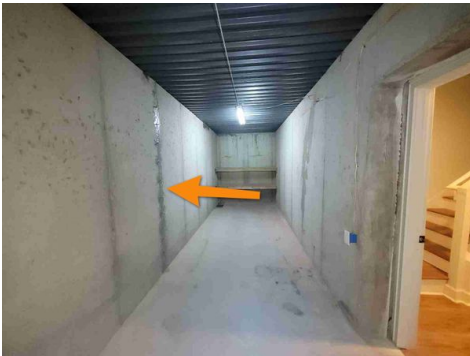
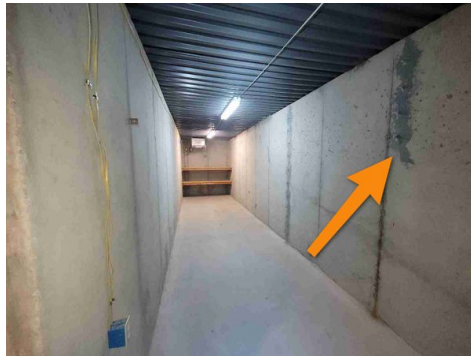
### 18.1.2 Foundation & Structure

#### **FOUNDATION - PRIOR REPAIR(S)**

Prior foundation injection repair(s) observed in the basement. Repairs appeared satisfactory. These types of repairs often have warranties. Inquire with the seller about any supporting documentation.

Contact the seller for more info

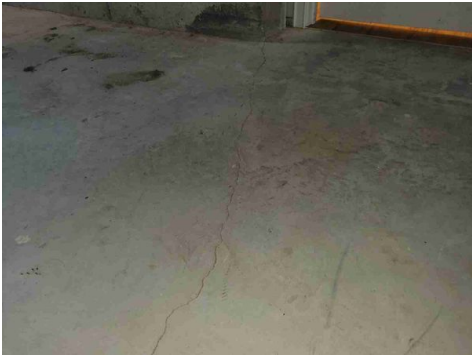
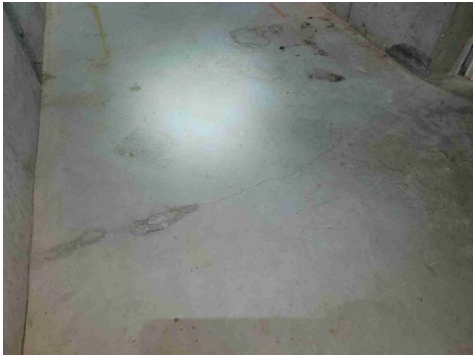
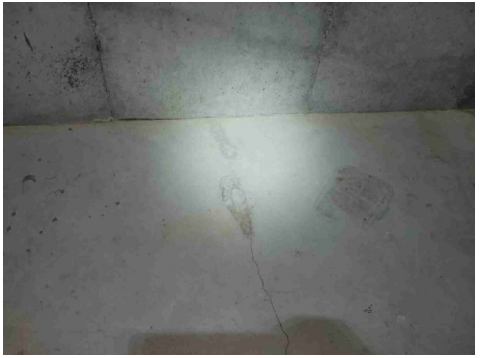
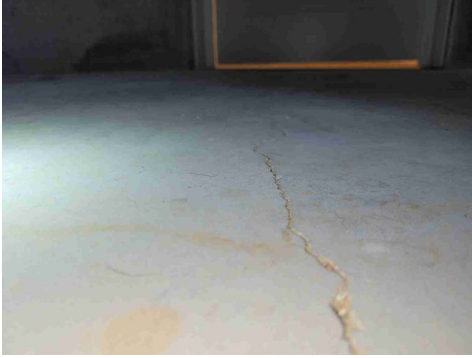
### 18.2.1 Basements & Crawlspaces

#### **SEALING - CRACKS/OPENINGS (BASEMENT SLAB)**

Recommend sealing the cracks/openings in basement slab to prevent ground vapor, possible radon gas and termite entry.

Contact a qualified professional.
