# ***R.B.G. Home Inspections, LLC***

301 W. Greene Street (Highgate Estates & Gardens)  
Greensboro, Georgia 30642

Prepared for: [Jeff Hough & Jack Rallo](#)

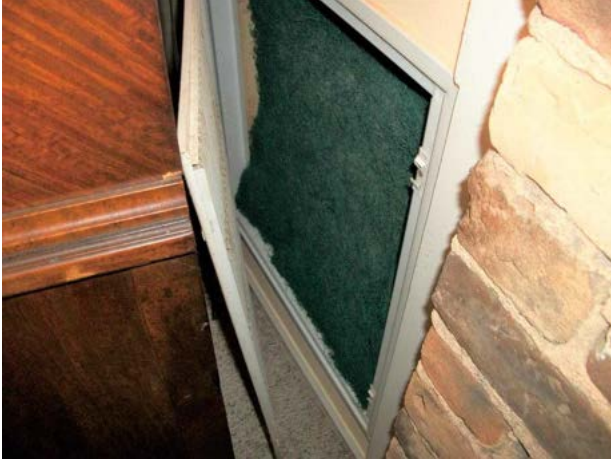
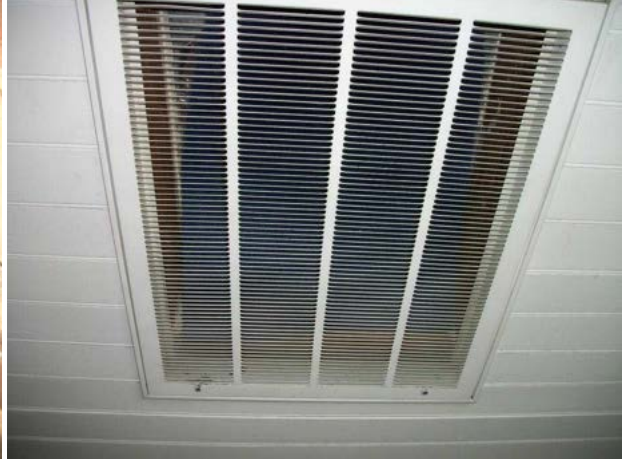
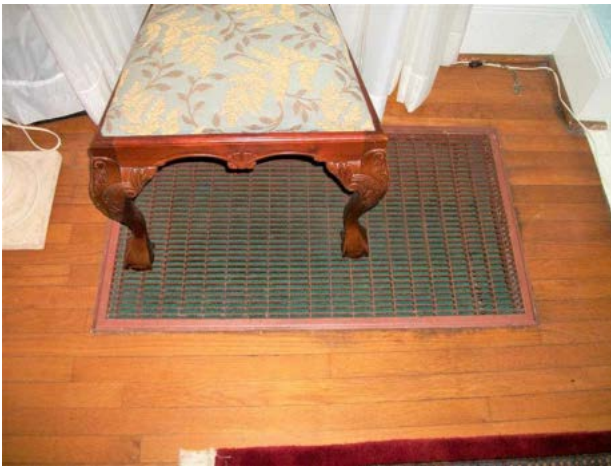
13. ☒ ☐ ☐ ☐ ☐ Filter Size: Washable type... FYI - filter locations.
